Protected Tree Report: Tree Survey, Encroachment, Protection and Mitigation

2235 N. Santa Anita Ave.
Sierra Madre, CA 91024

May 2014

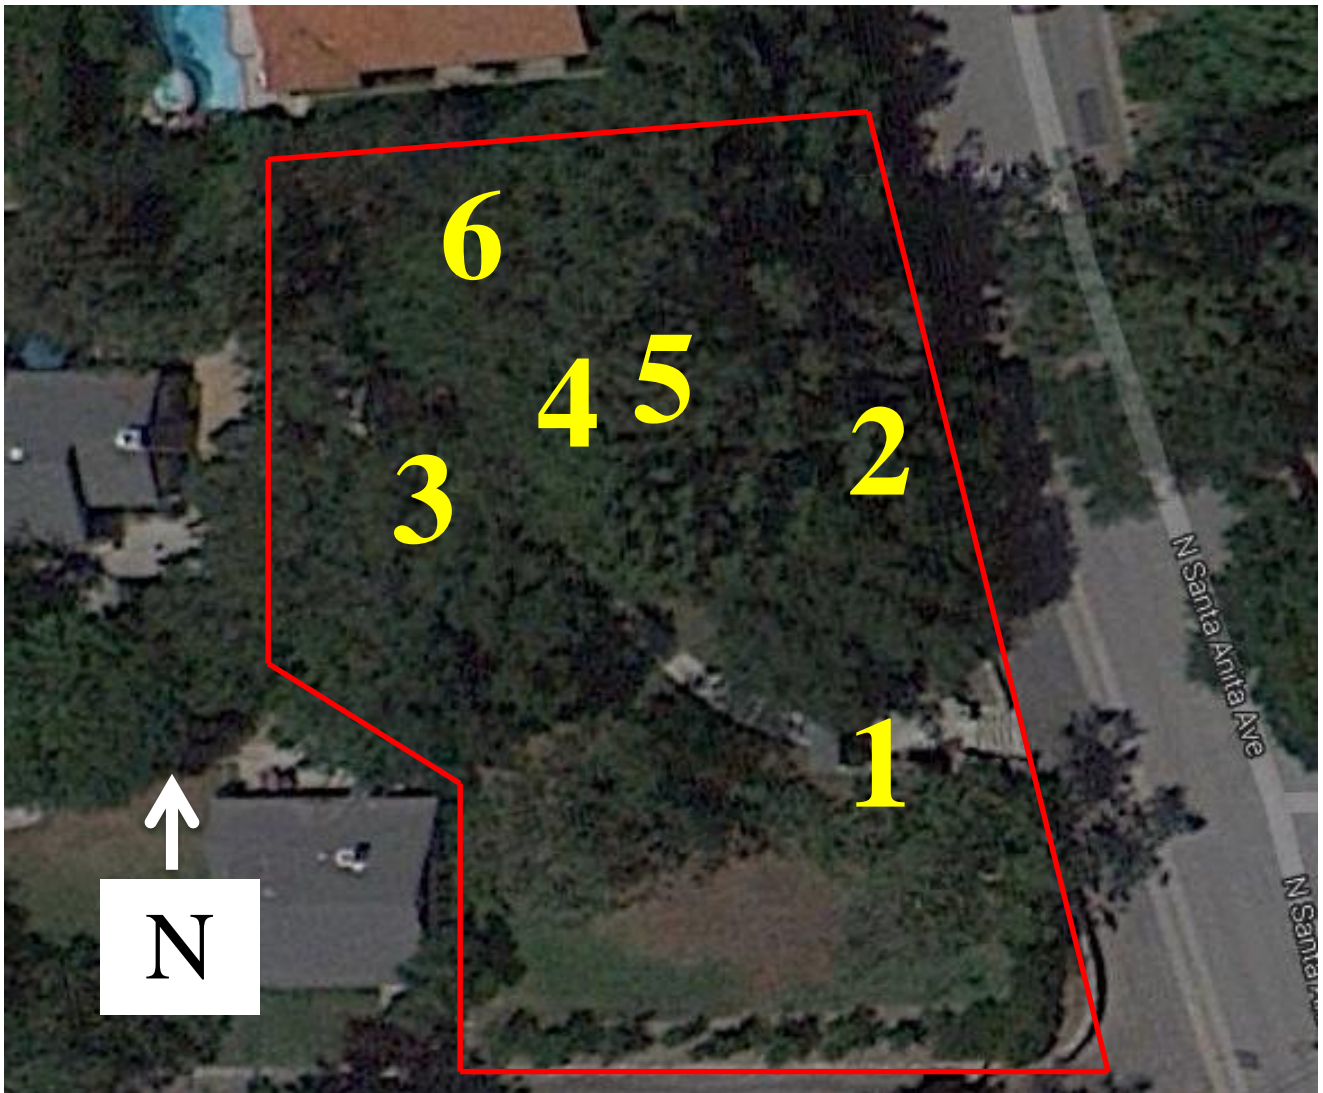
Aerial view and approximate boundary lines of property (red). Driplines of Protected Trees illustrated in yellow.(photo courtesy of Google Maps)

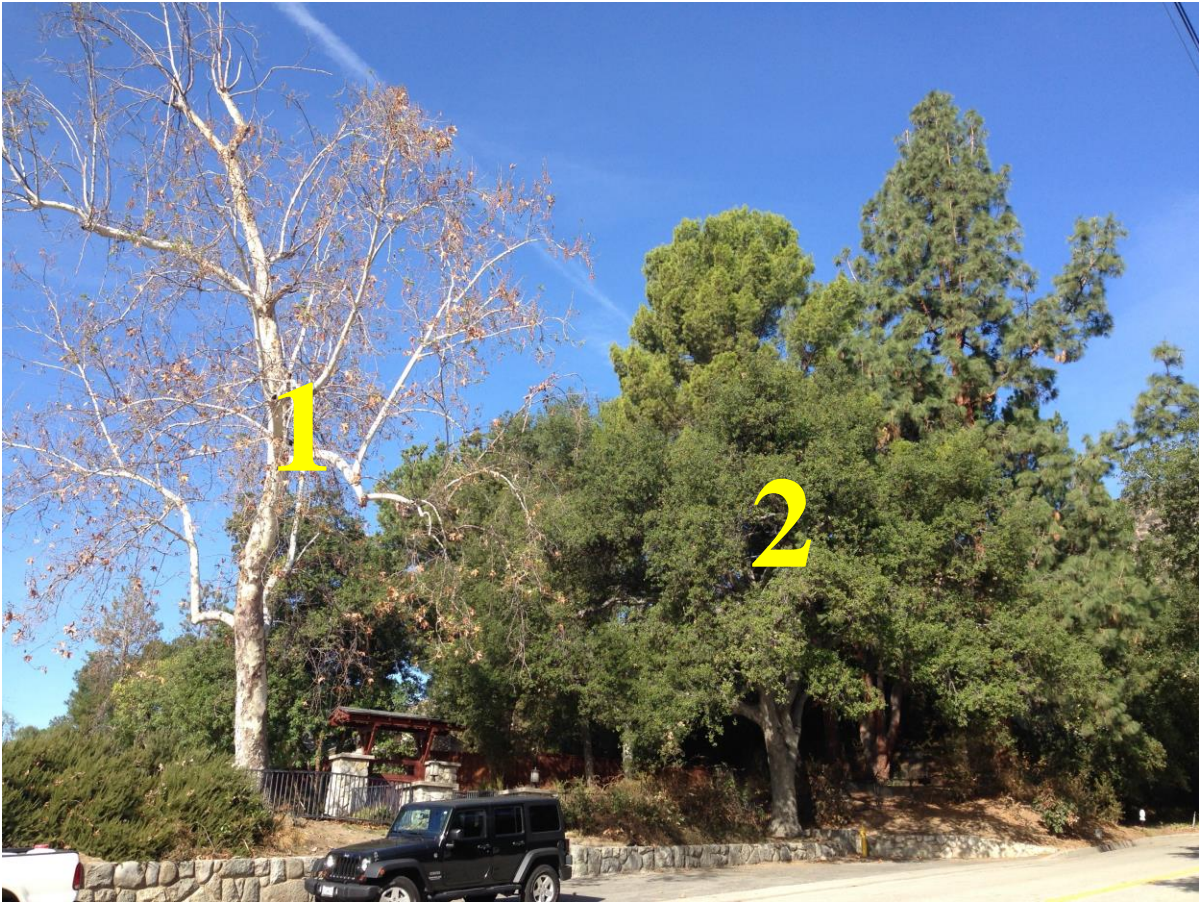
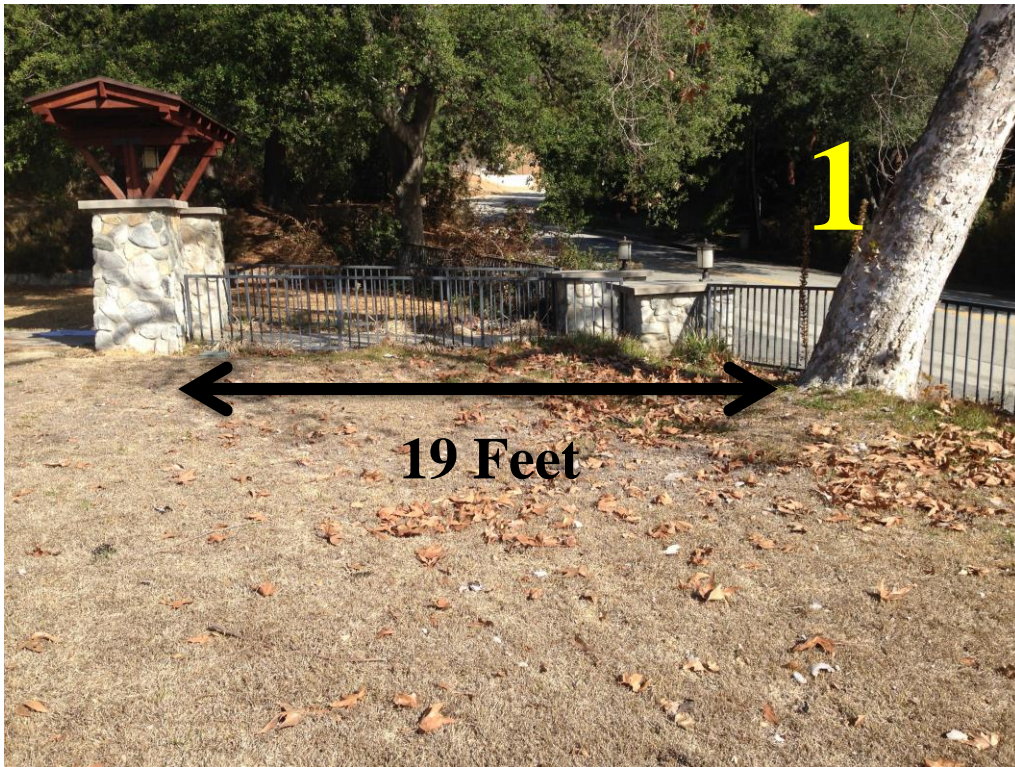
Tree #1 – 26” *Platanus racemosa*: The foundation of the new home will encroach. The home has been designed around two sides of the tree and the foundation will come as close as 11 feet from the trunk on the south and 18 feet on the west sides of the trunk. The existing rock and concrete entry will remain and a concrete walkway will be extended from this entry to connect with the front entry to the house. This walkway will come within six feet of the trunk on the north side. No pruning of the live crown will be required to complete the project.

ABOVE: Looking north towards Tree #1. The foundation will be located 19 feet from the trunk on its west side. BELOW: Looking west. The foundation will come as close as 11 feet on the north side of the trunk.

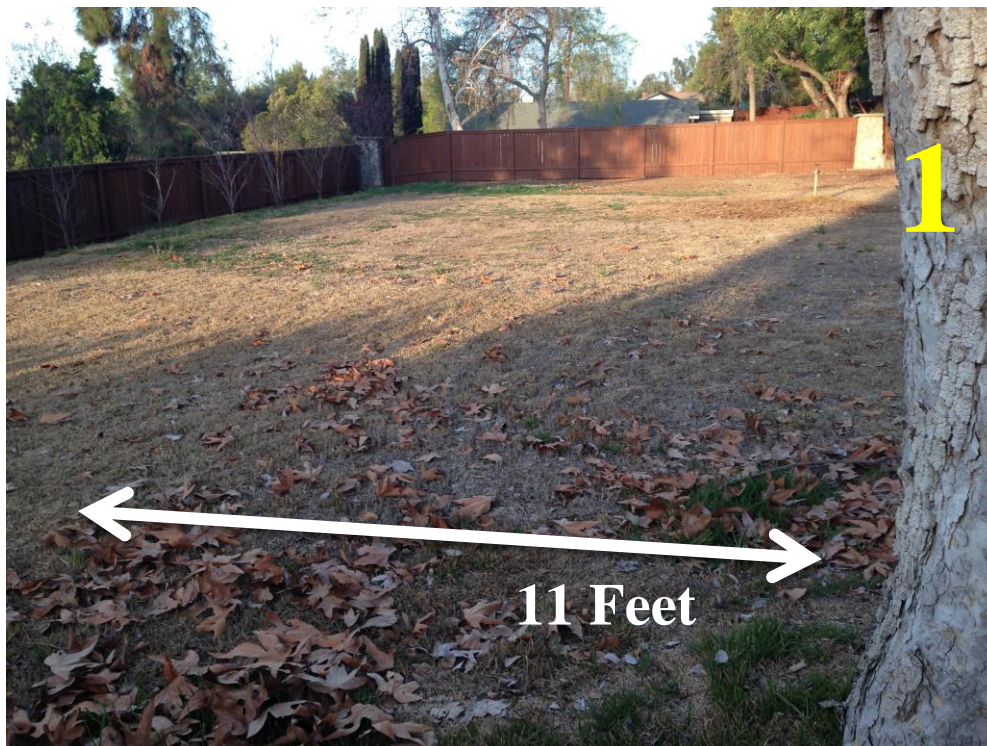
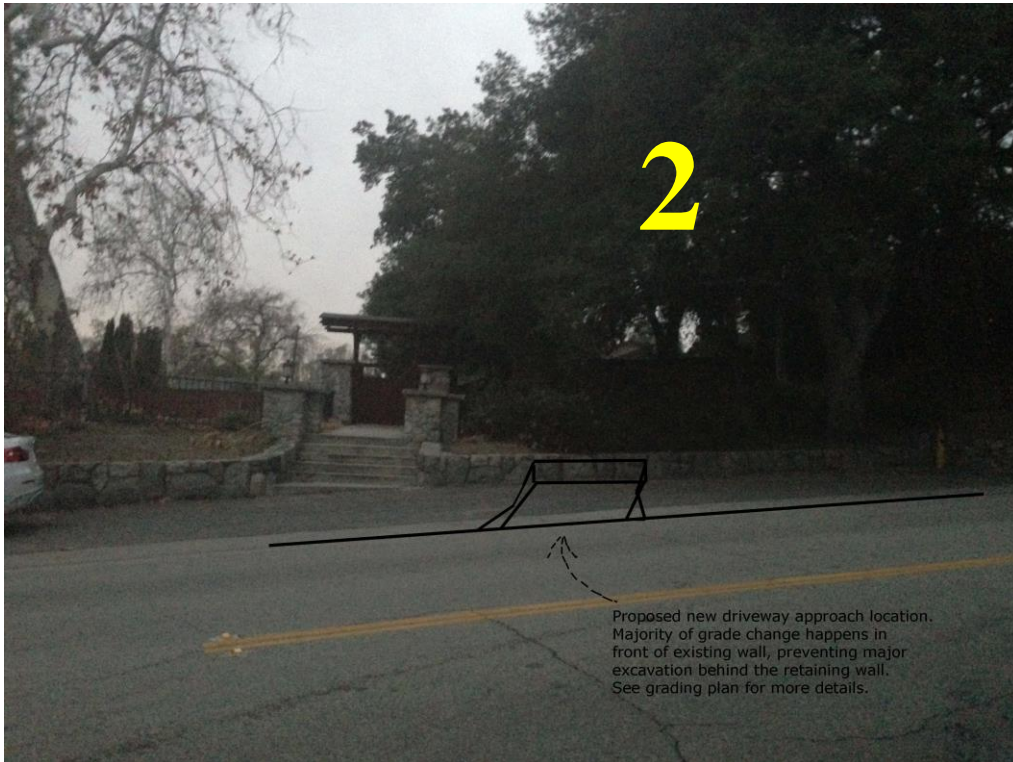
Tree #2 – 29” *Quercus agrifolia*: Encroachments will occur primarily from the installation of a new driveway and driveway entry on the south side of the trunk; and minimally from the foundation of the new home. The driveway entry will be built within the area located between the curb and existing garden wall, so will not require any excavation into the rootzone. Very light grading of a few inches will be required to

ABOVE: Looking west at Tree #2 from the street. A driveway approach will be built 13 feet from the trunk on its south side. The majority of the grade change for this approach will occur outside of the front garden wall. BELOW: Looking east. Once the grade for the driveway entry is achieved the driveway area will be built near grade with interlocking pavers set on a compacted sand base.

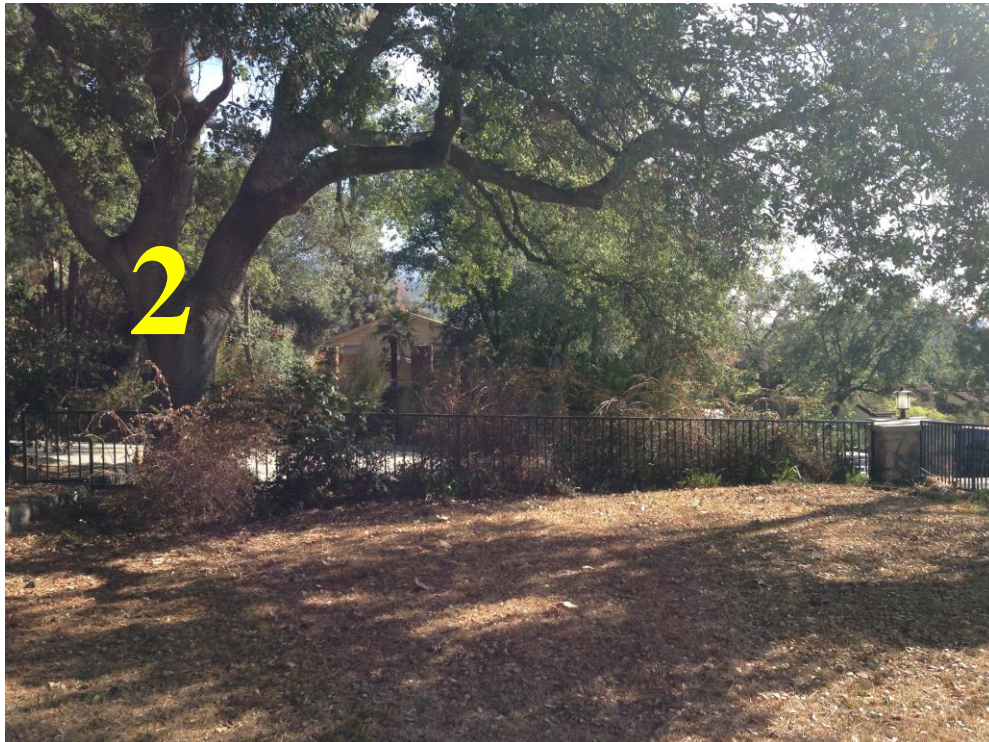
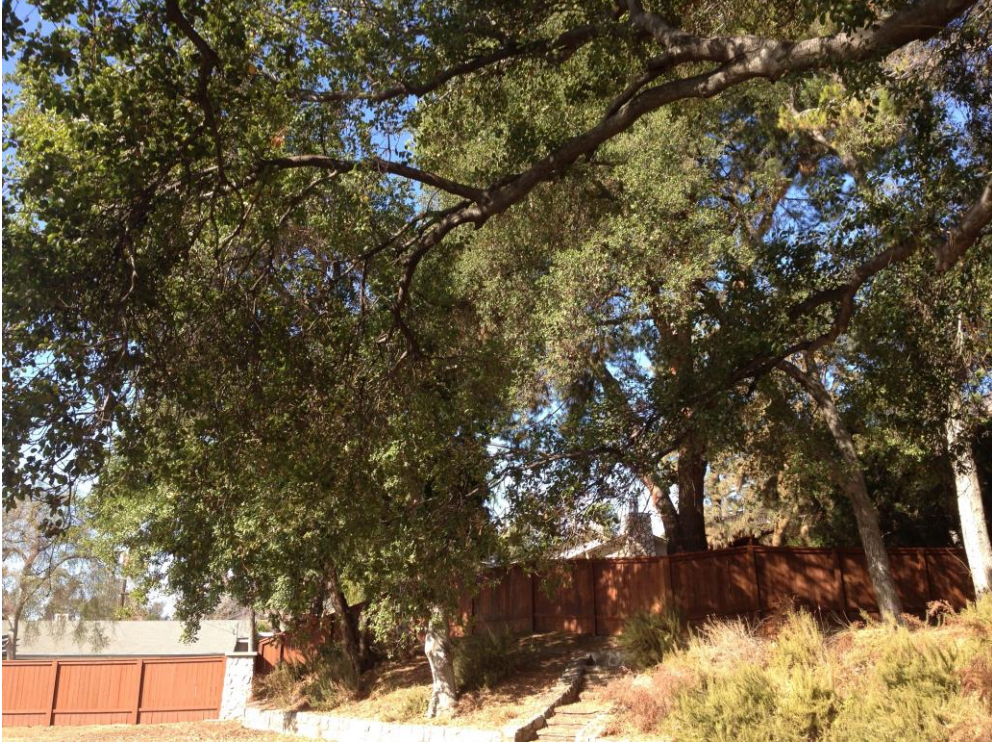
ABOVE: Tree #2 will need some crown raising type pruning over the driveway to accommodate the vehicle clearance. BELOW: A 6 inch removal cut of a loin's tailed branch will be required. Another 4 inch reduction cut will also be required

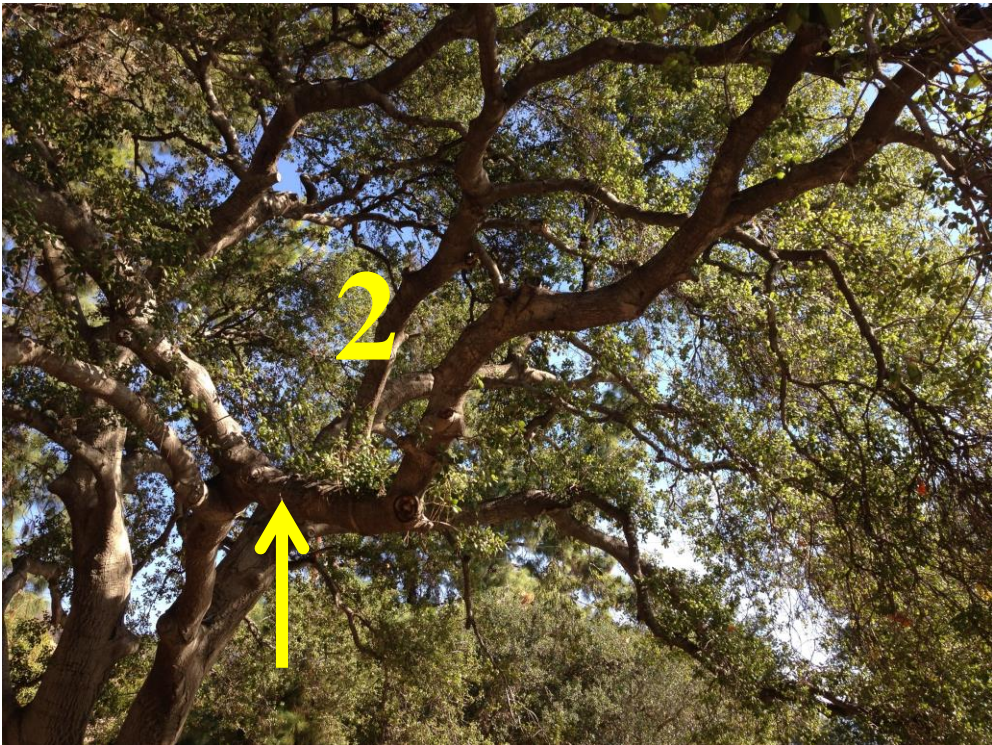
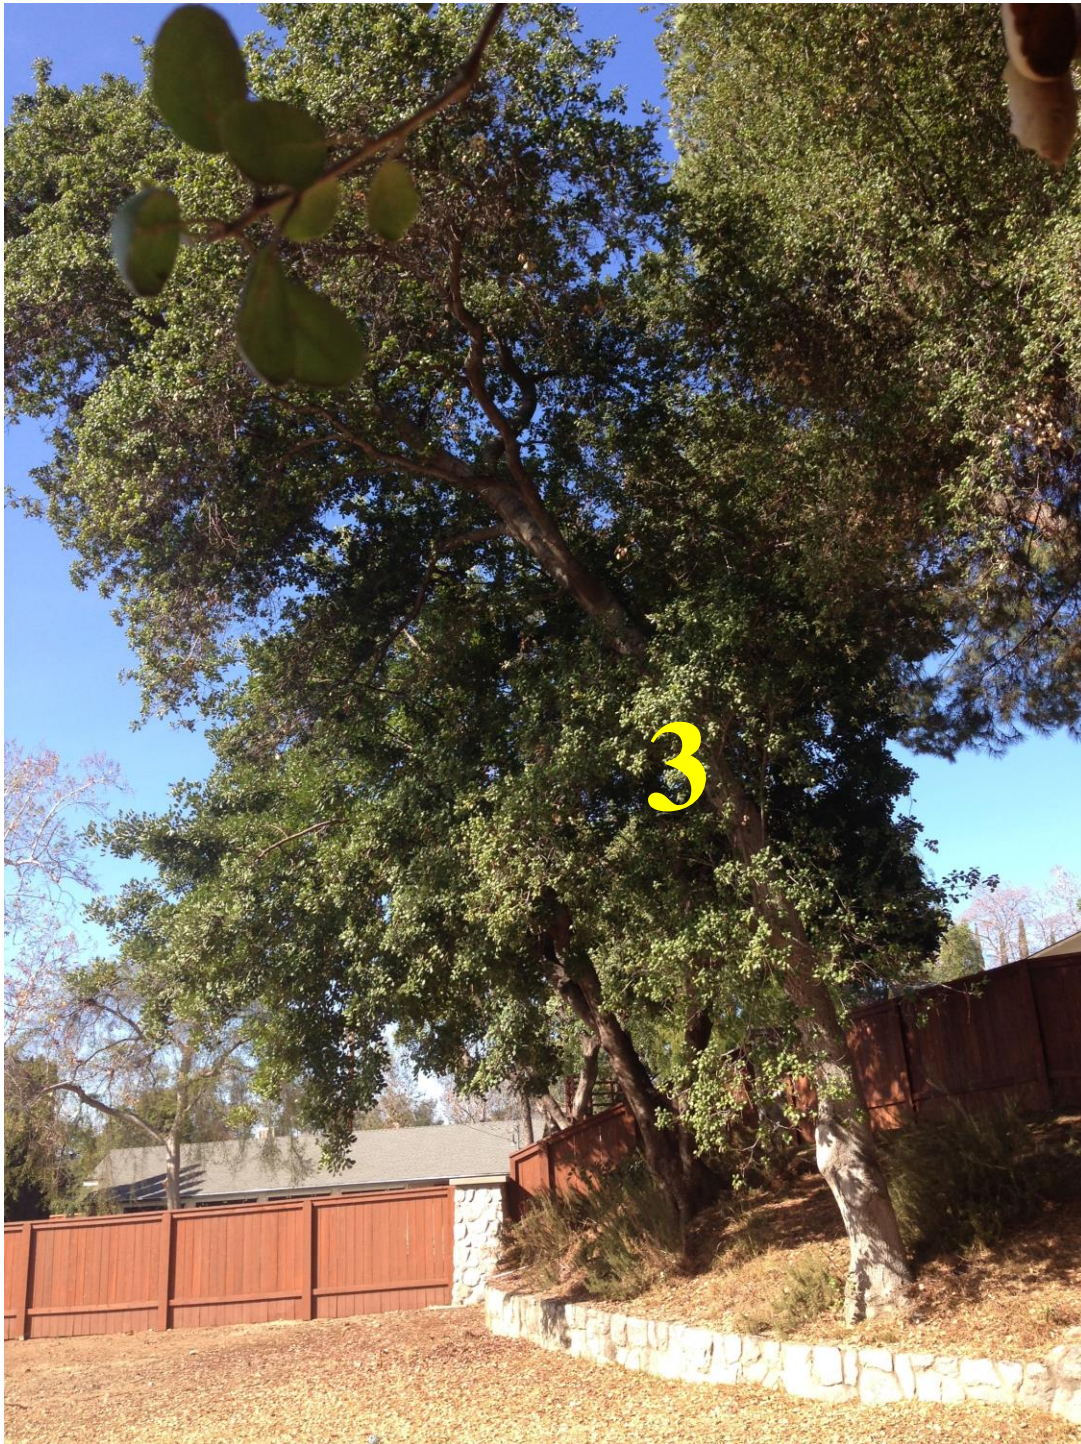
Tree #3 – 16” *Quercus agrifolia*: The foundation of the new home will encroach the dripline on the south and east sides, 5 feet and 12 feet from the trunk respectively. The tree is located just behind an existing retaining wall, which appears to be very substantial. This retaining wall has most likely restricted root growth beyond it so will act as an excellent buffer against impacts from the rootzone encroachment.

PHOTO: The new house will be built 5 feet from the trunk of Tree #3. It is located on a slope behind a rock retaining wall. Some slight crown raising will be required to accommodate the new roofline clearance.

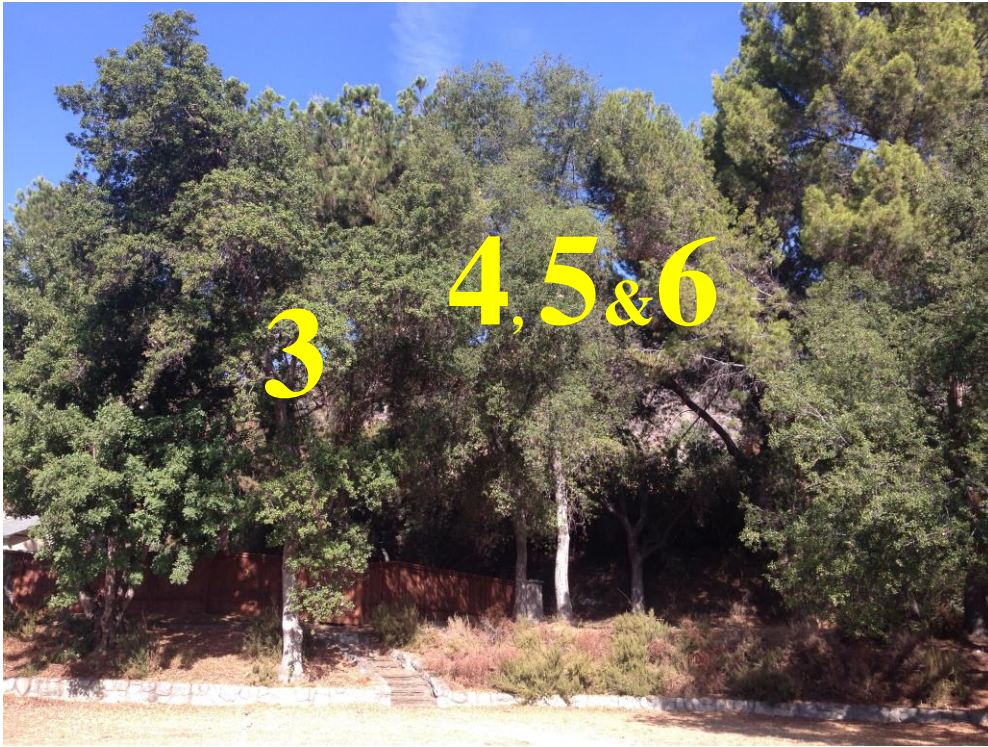
ABOVE: Trees #3-#6 are located on a slope above the large flat pad where the home will be built. BELOW: The four trees are contained behind a very substantial rock retaining wall. The footing of this wall has acted as a root barrier and will be a good buffer against rootzone impacts during construction.

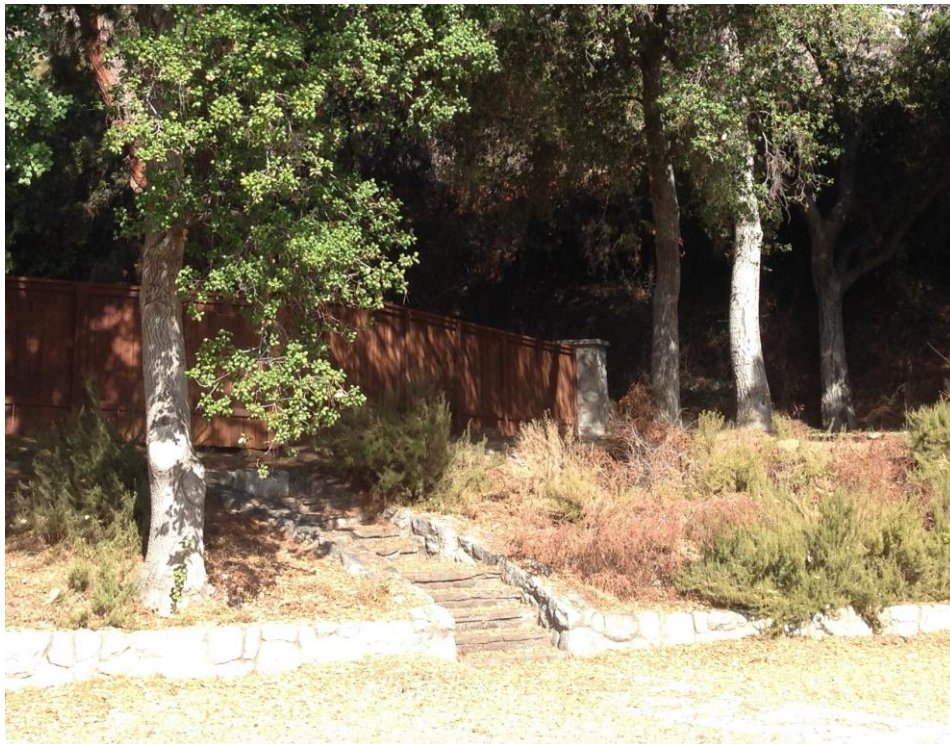
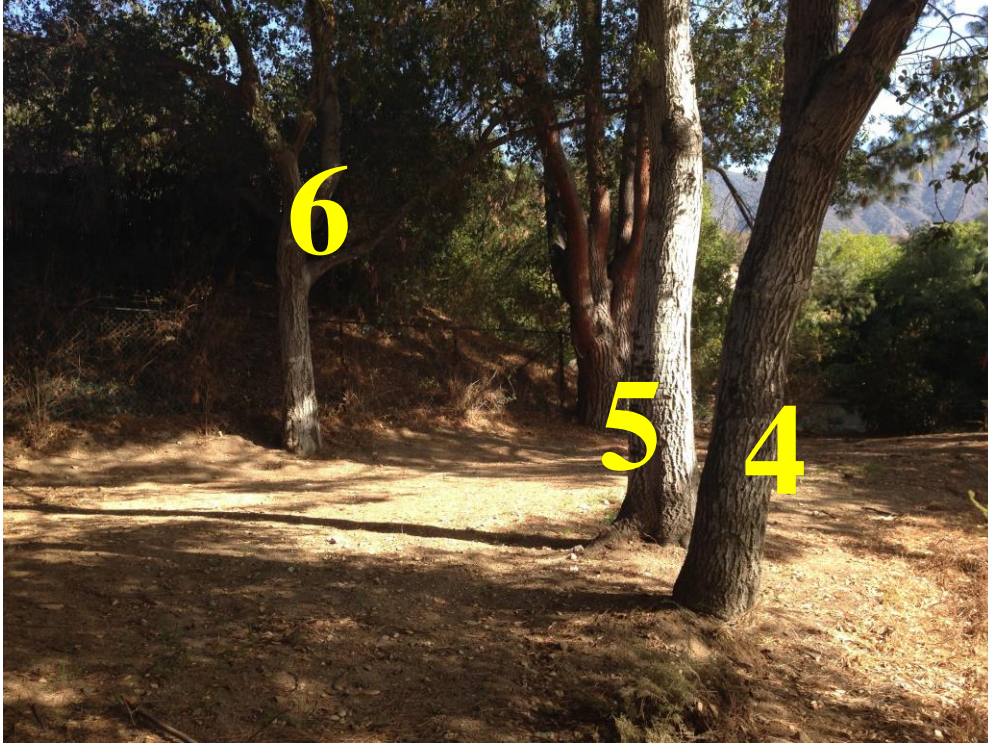
ABOVE: No rootzone impacts will occur on Trees #4, #5 and #6. The area will remain naturalized and non-irrigated. BELOW: The property line fences near Tree #6 will remain.
