Protected Tree Report: Tree Survey, Encroachment, Protection and Mitigation

2235 N. Santa Anita Ave.
Sierra Madre, CA 91024

May 2014

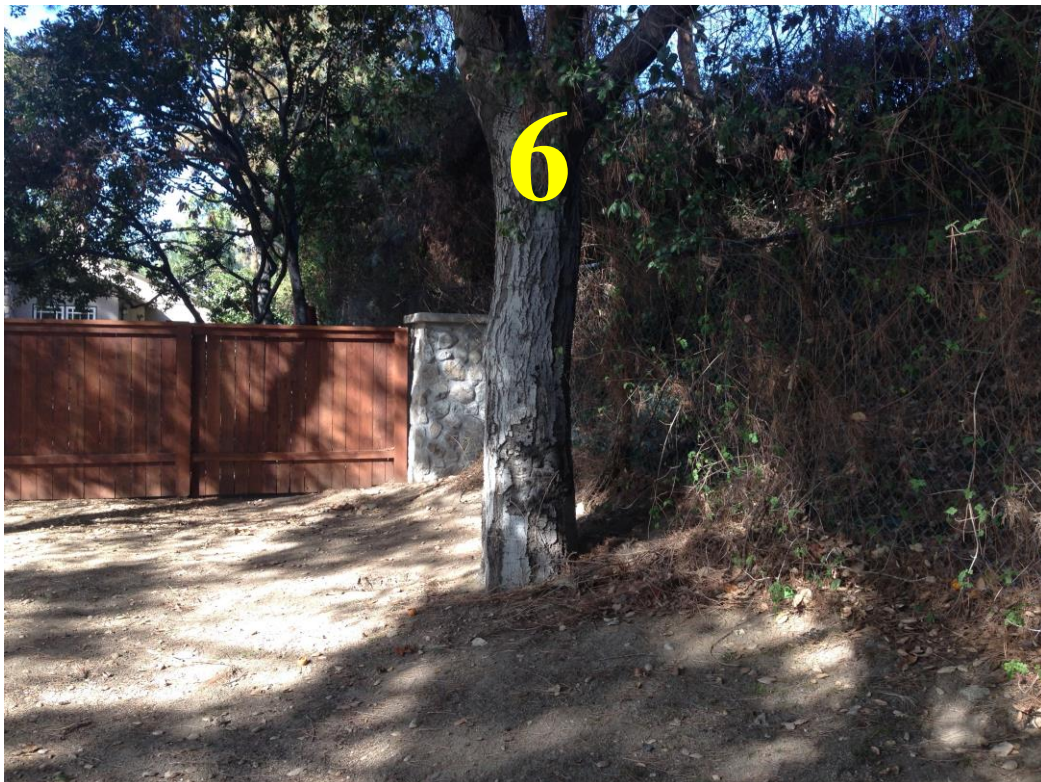
ABOVE: No rootzone impacts will occur on Trees #4, #5 and #6. The area will remain naturalized and non-irrigated. BELOW: The property line fences near Tree #6 will remain.
