**Sidewalk Master Plan
City of Sierra Madre
Public Works Department
January, 2015**

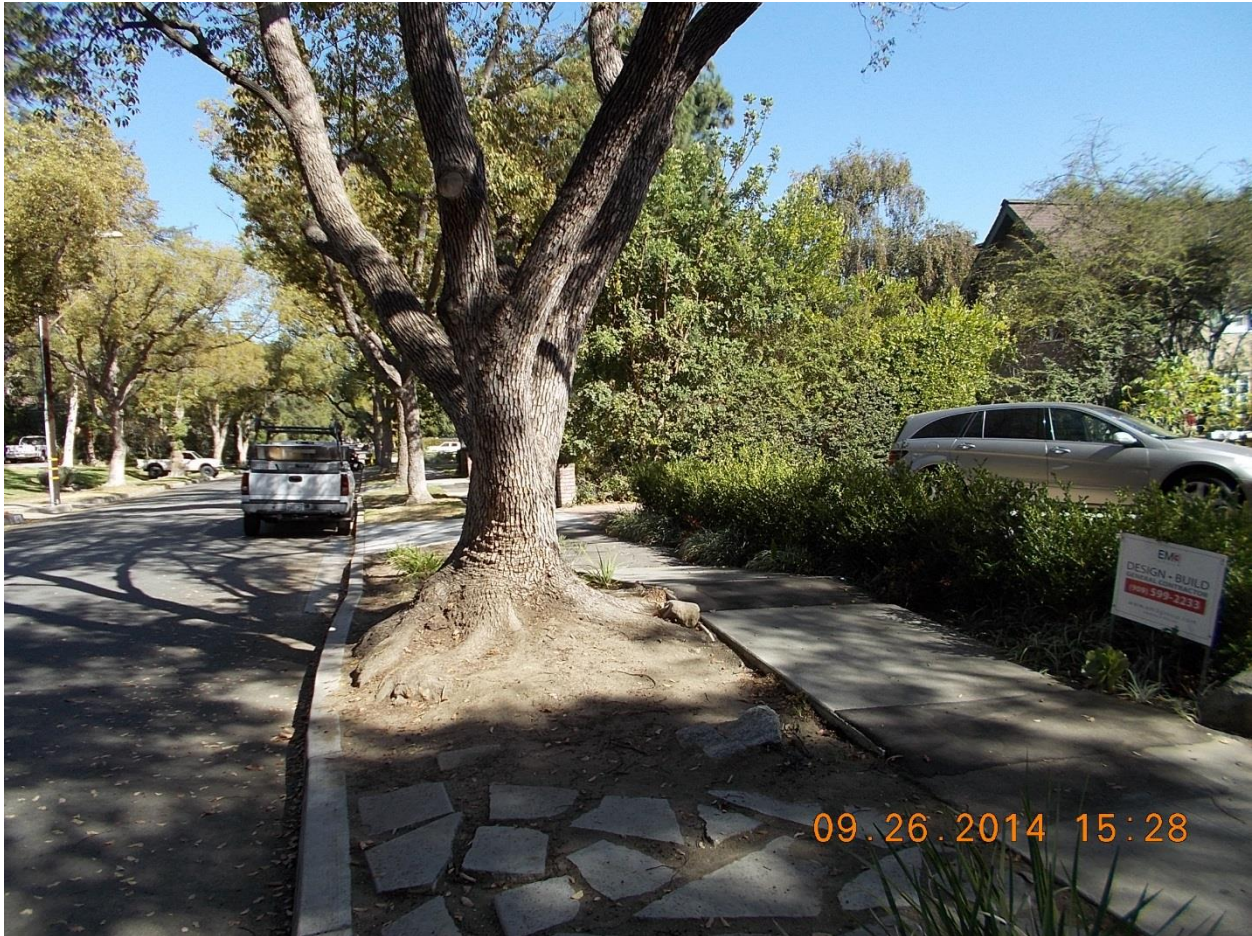
- The causes of root damage vary from shallow and surface roots in contact with the sidewalk to the radial growth increase of deeper roots causing sidewalk displacement. (figure 1) Sometimes the offending shallow or surface roots may be pruned. Relocating, narrowing, or modifying the sidewalk materials may reduce the need to root-prune.

Figure 1 Displacement caused by roots.

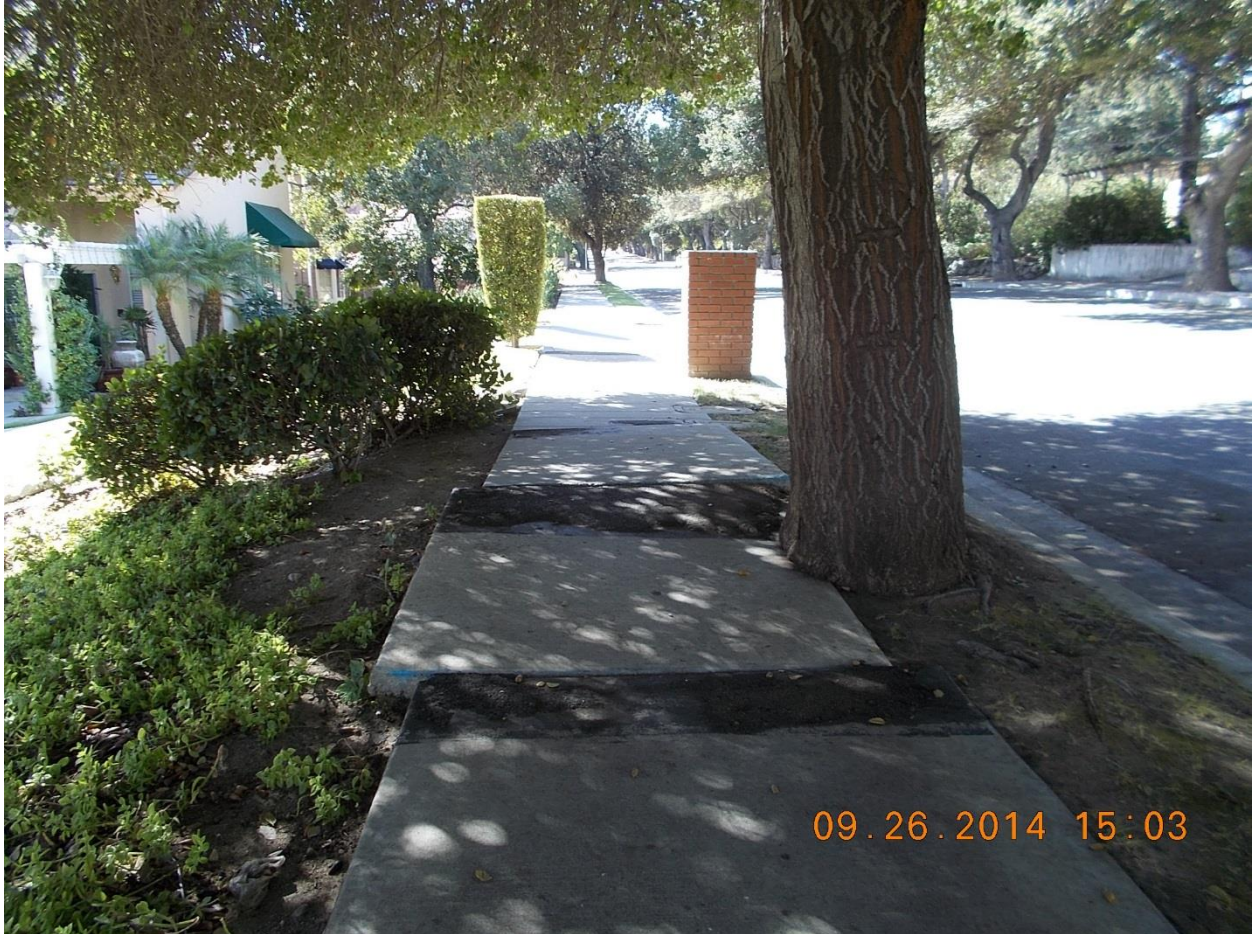
- The cause of trunk flare damage is a lack of space. This is commonly referred to as “Wrong Tree, Wrong Space”. The sidewalk is actually in contact with and lifted or offset by the enlarging tree trunk. Increasing the distance between the tree and sidewalk is the optimum way to correct this situation while retaining the tree. There are no opportunities to root-prune in this situation and put the sidewalk back in the same location. If the decision is to remove the tree the same damage can be expected in the future unless the site design is modified or a much smaller species of tree is planted. (figure 2)

Figure 2 Displacement caused by trunk.

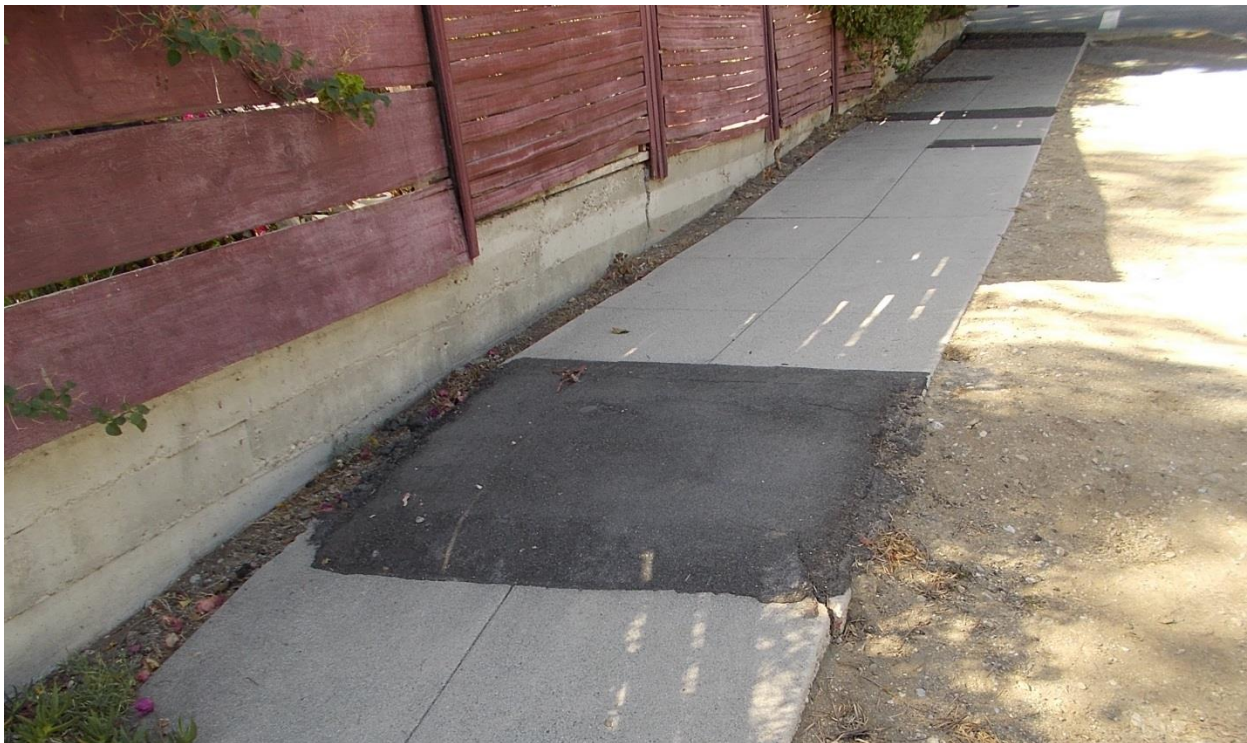
This program has been used by Public Works Crews for the last 2 $\frac{1}{2}$ years and has provided a method of using field logs during inspections, and then the manual entry of inspection results into an Excel database. (**Appendix B**) The current Sidewalk Inspection shows a total of 610 locations in the city that need repair. Of the 610 locations, 281 repairs have been made as of the end of calendar year 2014. Many of these repairs were made to the highest priority locations and done with asphalt patching (figure 3) or concrete grinding to eliminate immediate hazards.

Figure 3 - Asphalt patching

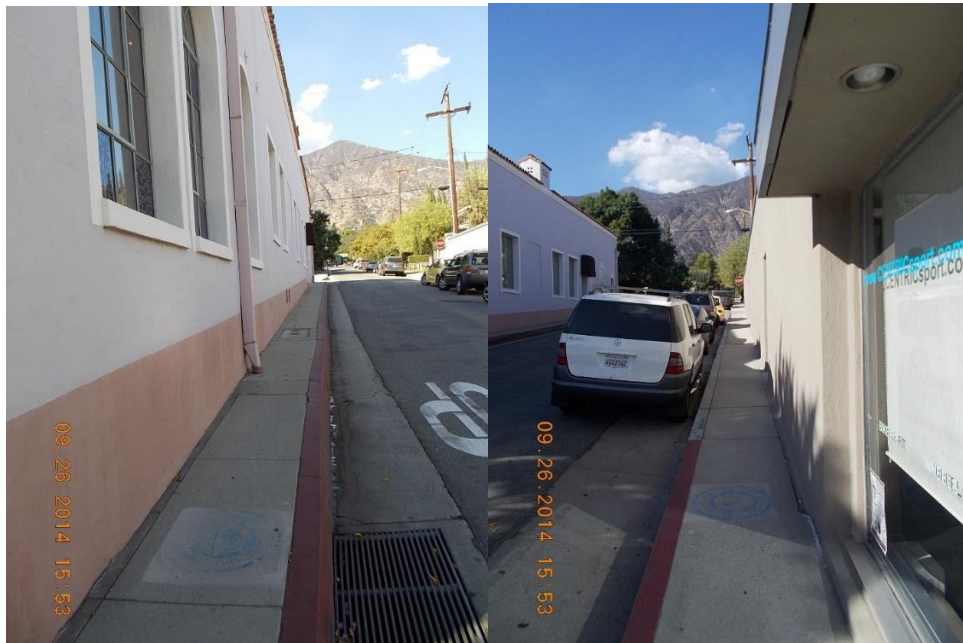
Figure 5 below shows Windsor Lane, looking north from W. Sierra Madre Blvd. The challenge at this location is the 4-foot minimum width requirement. This narrow sidewalk exists on both the east and west side of the street, and both sidewalks have structural walls on their sides. The only feasible project to come into compliance at this location would most likely include making this a one-way street and widening one or both of the sidewalks.

Figure 5 – Windsor Lane

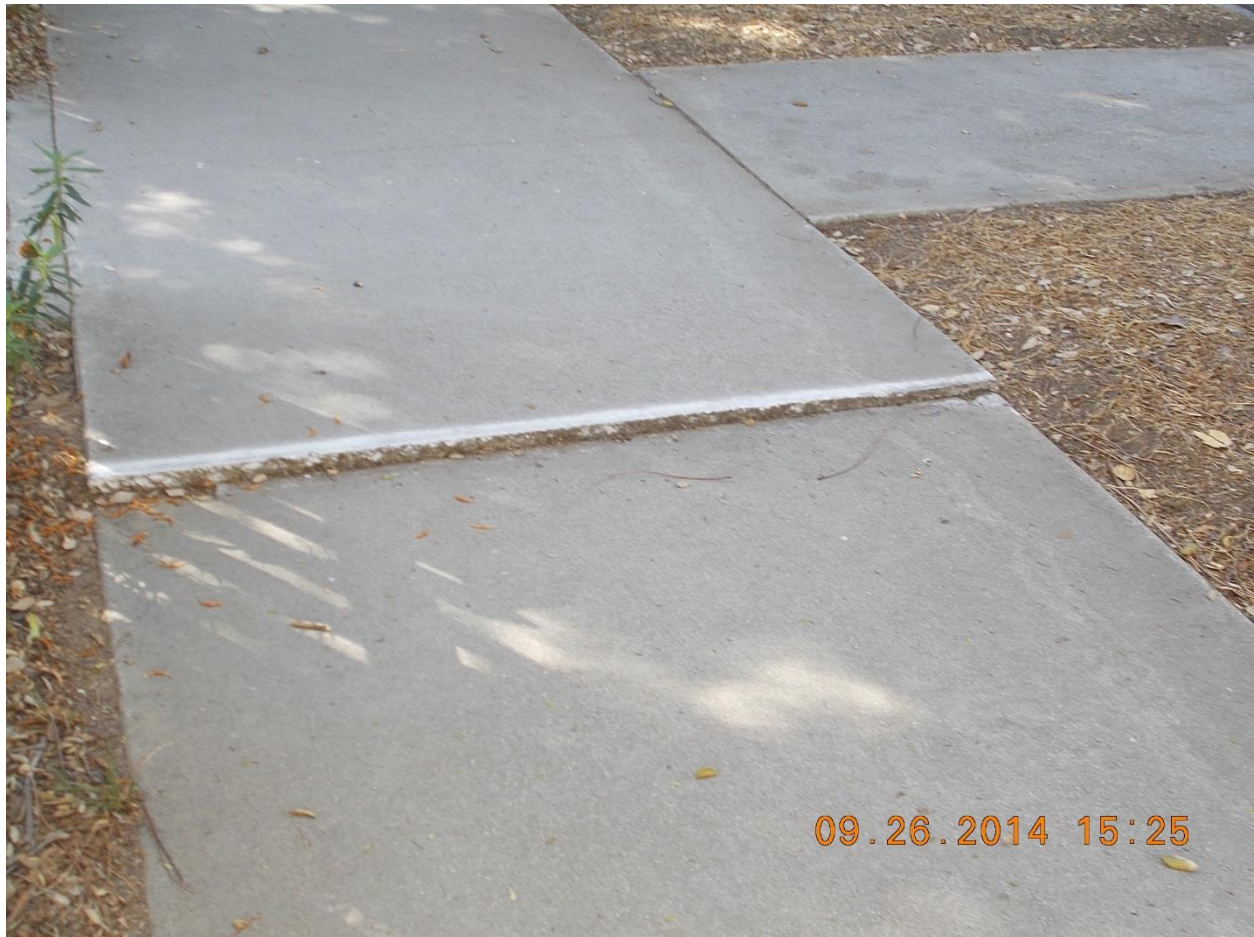
The most common challenge is the displacement of $\frac{3}{4}$ inch or greater. As previously mentioned, our inspection data shows 610 identified sites for repair. The majority of these sites are concerned with displacement. Our data shows that of those 610 identified repair sites, 281 have had temporary repairs made. Figure 6 below shows a displacement of over an inch; this is an example of a high priority location that would be addressed quickly. (It was repaired shortly after the picture was taken.)

Figure 6 - High priority displacement site

Objective 1c: It is recommended that the Sidewalk Inspection Program add one element which has not been done consistently. Marking identified defects with white paint (reflective if possible) (See Figure 6 for example) would serve the purpose of short-term identification of a potential hazard as well as preventing the defect from being entered into the database on multiple occasions. This would also assist the staff with customer service by being able to quickly confirm to an inquiring resident with an assurance that the defect has been identified and is queued for repair based on its level of prioritization.

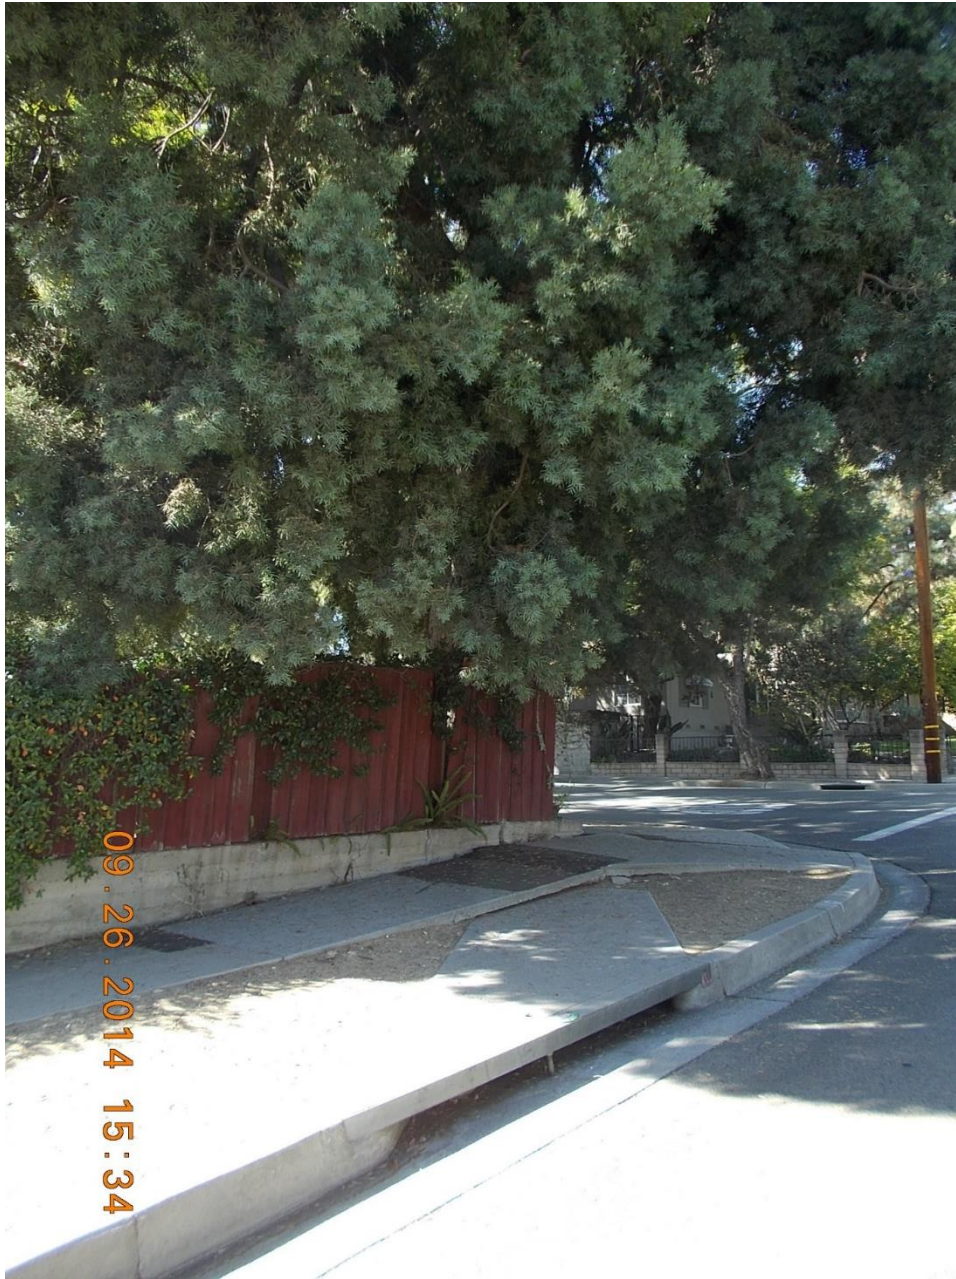
Sloping issues are also a concern with an eye for ADA compliance. In figure 7 below, the location was raised considerably by tree roots, and then asphalt repairs also add to slope concerns. This location is close to, if not exceeding, the 5:1 slope ratio.

Figure 7 - Slope concern

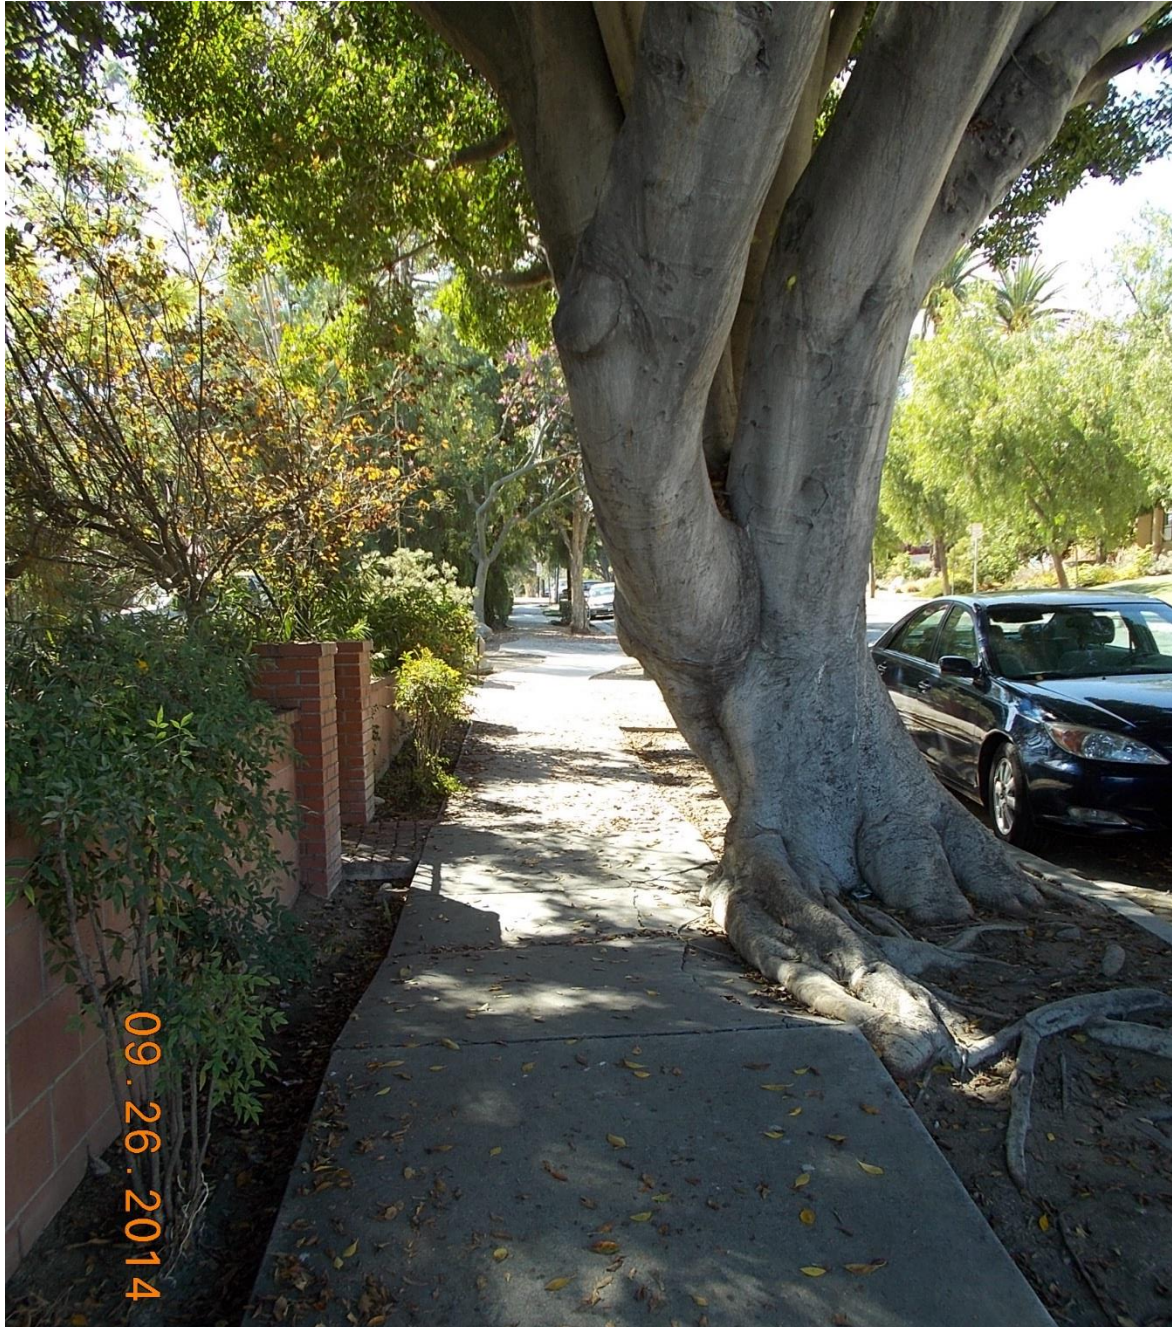
While vertical and horizontal clearance is less of an issue within our sidewalk system, these concerns exist and must be addressed. If the clearance problem is due to relatively small branches, the correction can be done rather easily, however, the branches may grow back and the lack of clearance can become an ongoing issue. In figure 8 below, there is an example of a more challenging horizontal clearance issue.

Figure 8 - Horizontal clearance issue.

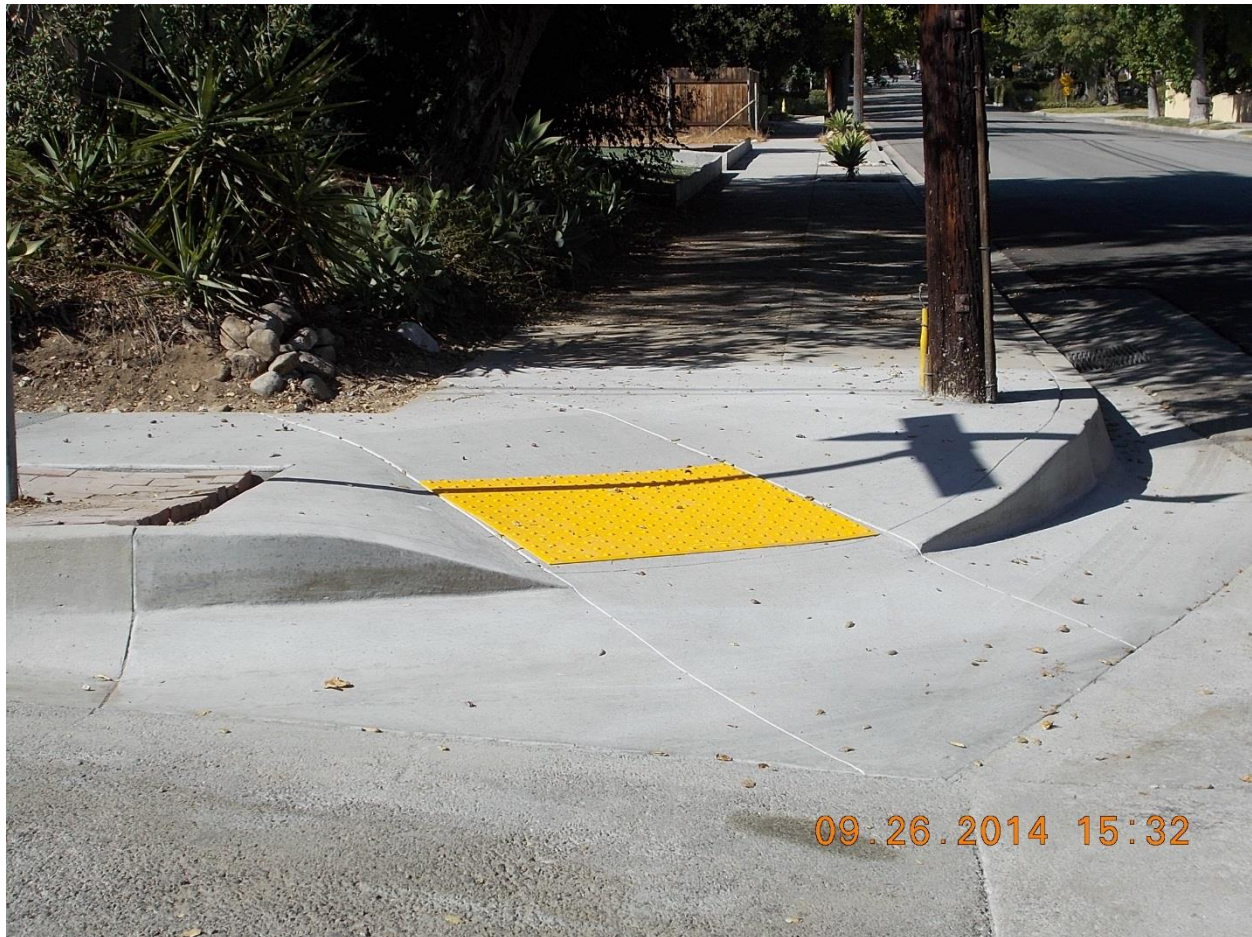
Ramping at intersections is required to be done when sidewalk repair occurs at these locations. Fortunately, Sierra Madre has “chipped away” at upgrades for these locations at a good pace. In 2014, with funding in the amount of approximately \$45,000.00 from a Community Development Block Grant (CDBG), 22 new ramps were installed. Figure 9 is one of the locations that had a ramp installed in the past month. All intersections now have ramps.

Figure 9 - Recent ramp installation.

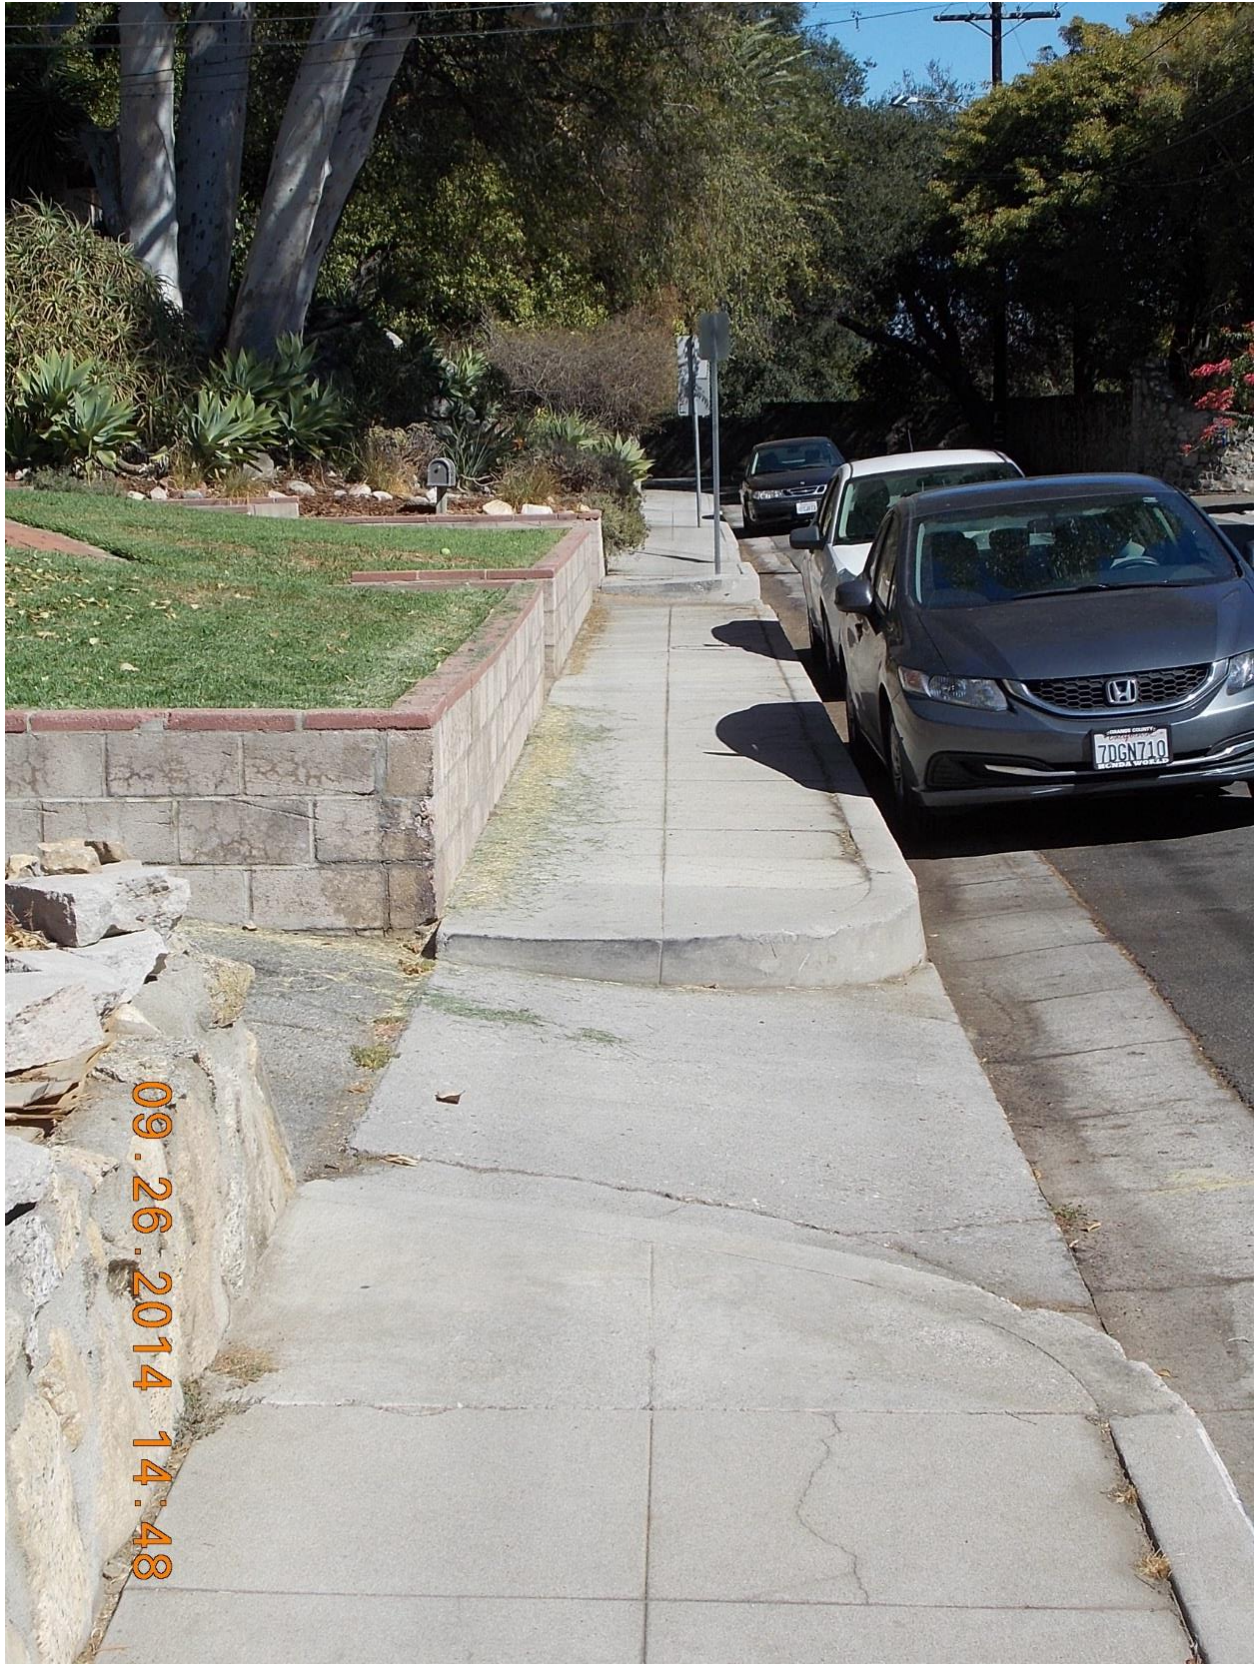
The sixth primary concern can be considered as maintaining the consistency of a sidewalk that is designed to provide safe access for differently-abled pedestrians. On Sturtevant Drive, which is basically the only sidewalk in the Canyon areas, the sidewalk is very inconsistent. This is due to the varied styles of sidewalk and driveway approach interaction.

Along this sidewalk, there are sloped driveway approach transitions along with “curbed” transitions. This is also representative of a situation in which there is no “one-size-fits-all” remedy. The topography surrounding the sidewalk presents unique challenges as the private driveway is on a much lower grade than the street and makes this transition difficult.

Figure 10 - Looking east on Sturtevant Drive.

transition for a pedestrian using wheeled transportation. See figure 10; the Sturtevant Drive sidewalk as an example.

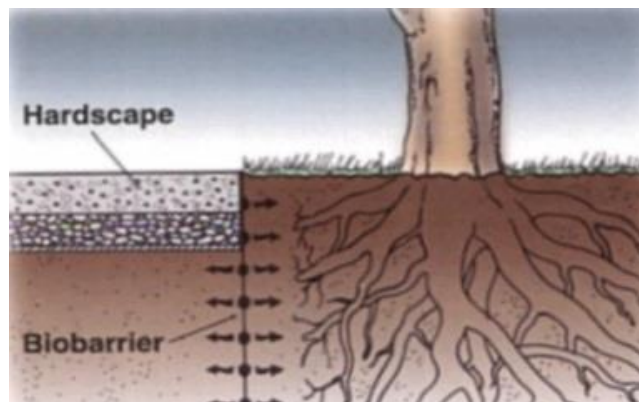
- Masonite type forms are preferred for curb and gutter construction because they minimize excavation. This method should be used in the Critical Root Zone. Where appropriate, use curbs with discontinuous footings to maintain natural grade near the base of trees adjacent to the curbing and to minimize injury to roots and root flares.
- “Tyvar BioBarrier” may be used between the curb and tree roots to inhibit root growth that may exploit small cracks in the curb.

Figure 11 - Biobarrier installation

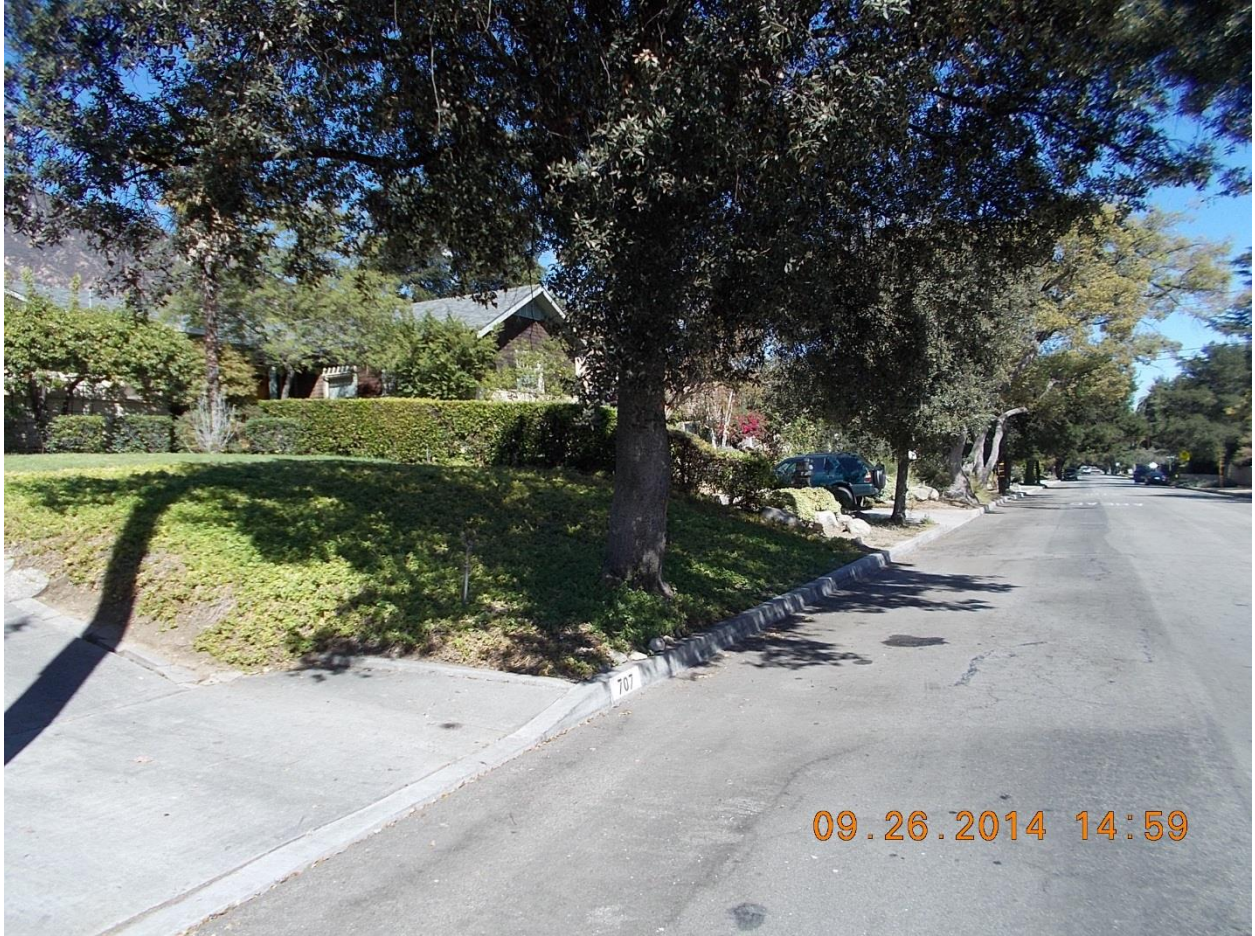
This plan also includes a series of City Sidewalk Maps (**Appendix F**) that provide a “snap-shot” of where sidewalks currently exist and where they do not. The maps show existing sidewalks in **blue**. It also shows streets that do not have sidewalks in **green**. The areas in **green** indicate that there is current landscaping that extends to the curb. On many streets, this is very consistent, and the addition of a sidewalk along these streets could have a major effect on the look of the street and require the removal of many trees. (See figure 11)

Figure 12 - Landscaped to the curb.

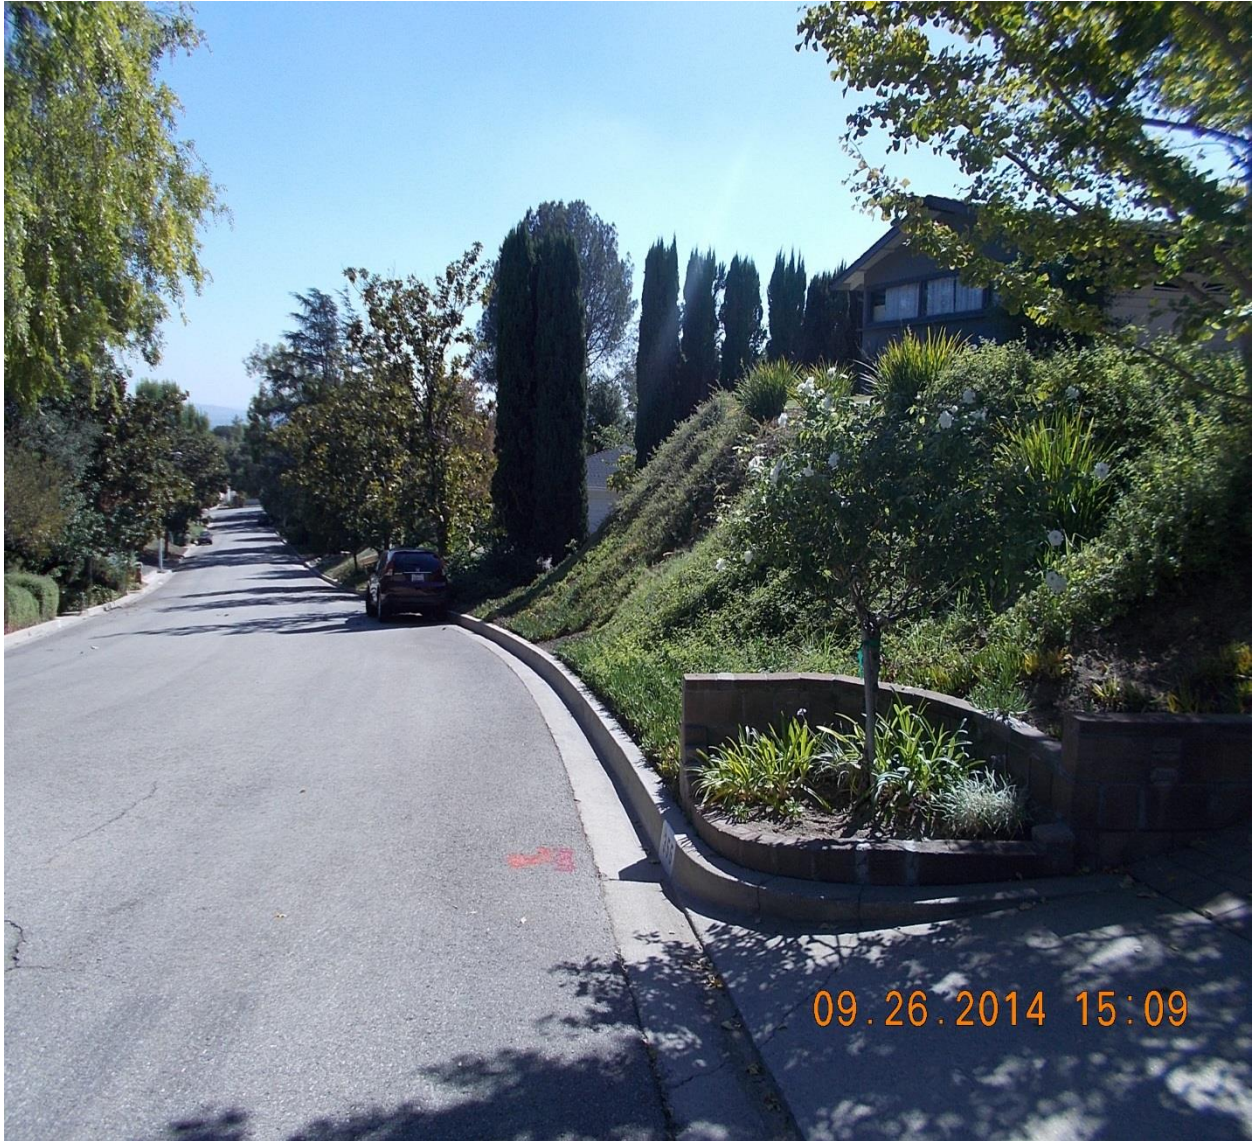
The **green**-outlined streets in the sidewalk maps may also represent a condition in which not only is the property landscaped to the curb, but there are also topographical conditions that would prevent a sidewalk from being installed. Fortunately in Sierra Madre, many of these scenarios exist in cul-de-sacs in the northern portion of town, such as Sierra Meadow Drive and Toyon Road where pedestrian traffic is very low.

Figure 13 - Landscaped to the curb and steep topographical condition.

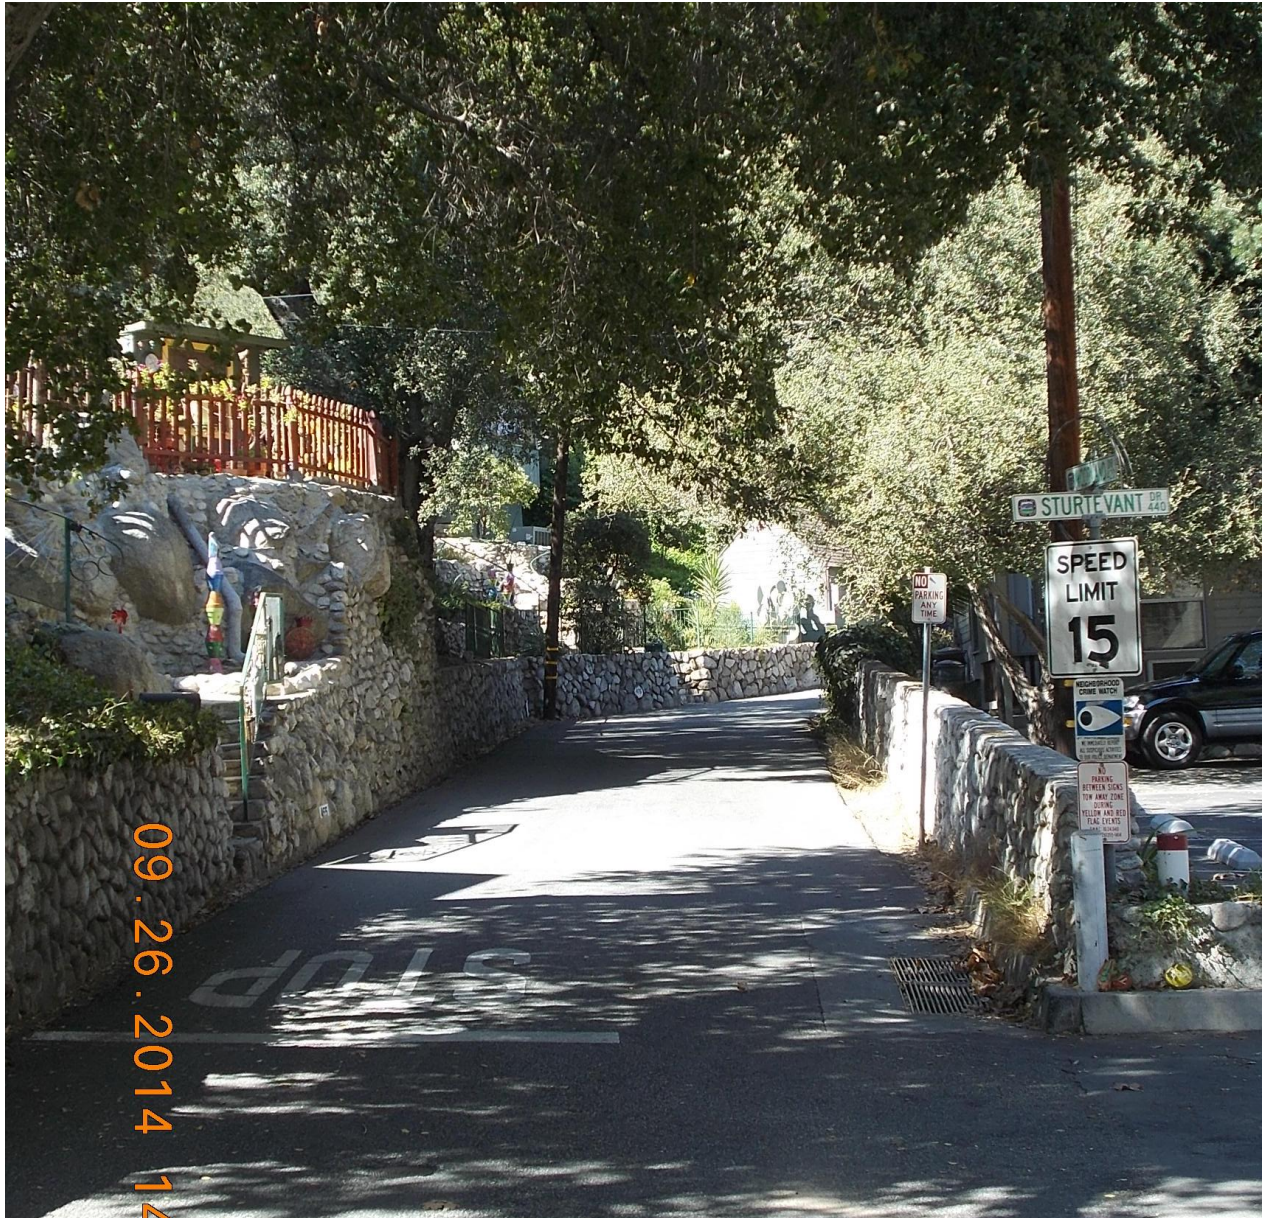
Finally, a **green**-outlined road may also indicate that there is simply no opportunity to install a sidewalk in the public right-of-way. Virtually the entire Canyon area of Sierra Madre is in green, and figure 13 below clearly demonstrates this condition.

Figure 14- Canyon area, Woodland Drive looking north.

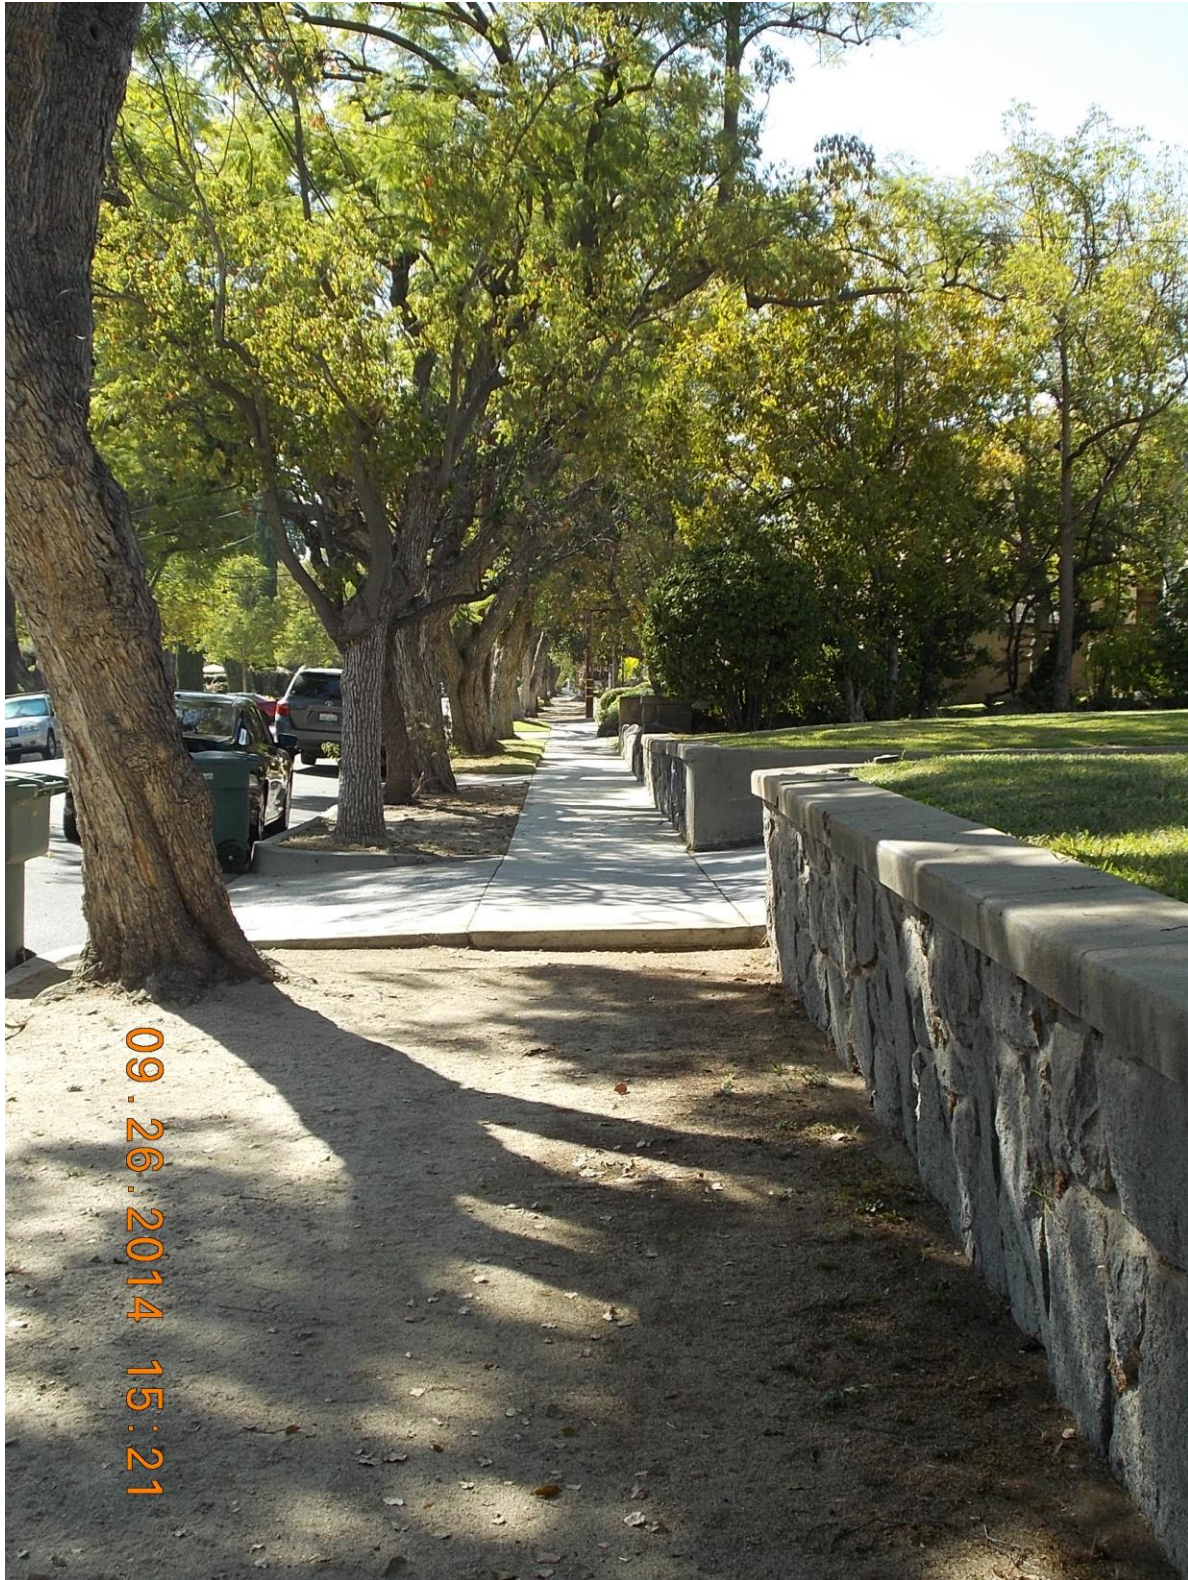
The sidewalk maps also have portions of streets with a **yellow** outline. This third color was needed to show areas that do not have sidewalks, but have either intentional or unintentional footpaths. Figure 14 below shows a footpath that is created when a significant portion of the side of the street has a concrete sidewalk but the sidewalk is not continuous. When the sidewalk ends, pedestrian traffic continues. A concern for this situation is the 4 to 6 inch displacement that commonly occurs when the sidewalk ends. Figure 15 on page 24 illustrates an example of the vertical displacement occurring at the juncture of a concrete sidewalk and an unmaintained parkway.

Figure 15- Unintentional footpath. West Montecito Ave.

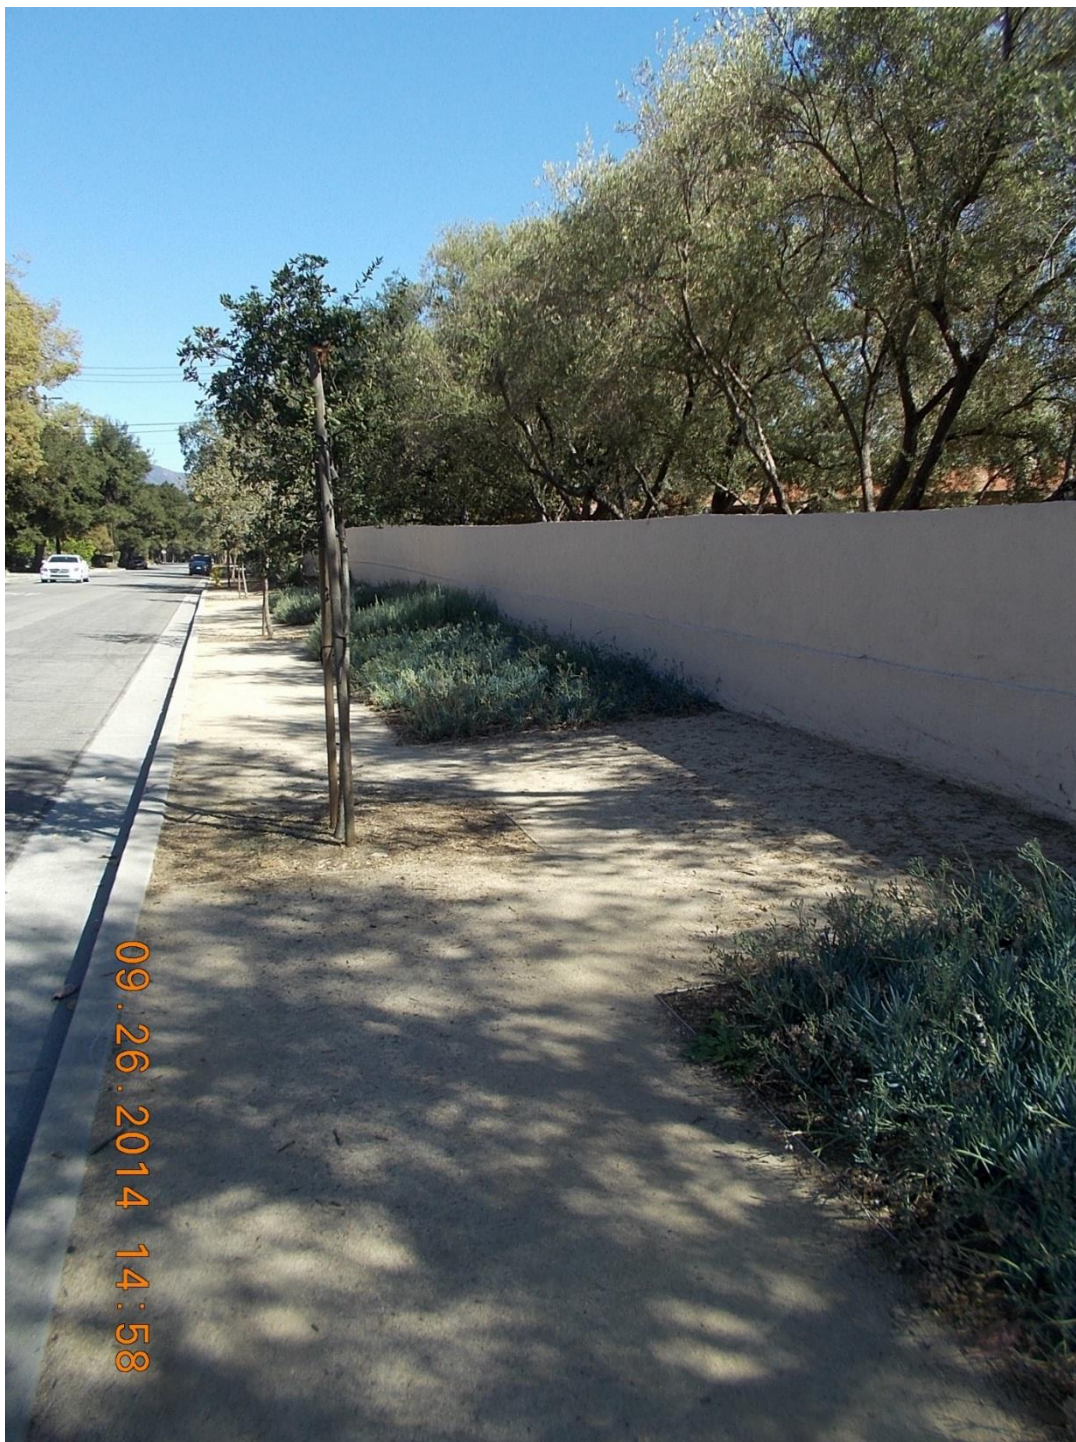
Figure 16- Intentional footpath. West Grand View Ave.

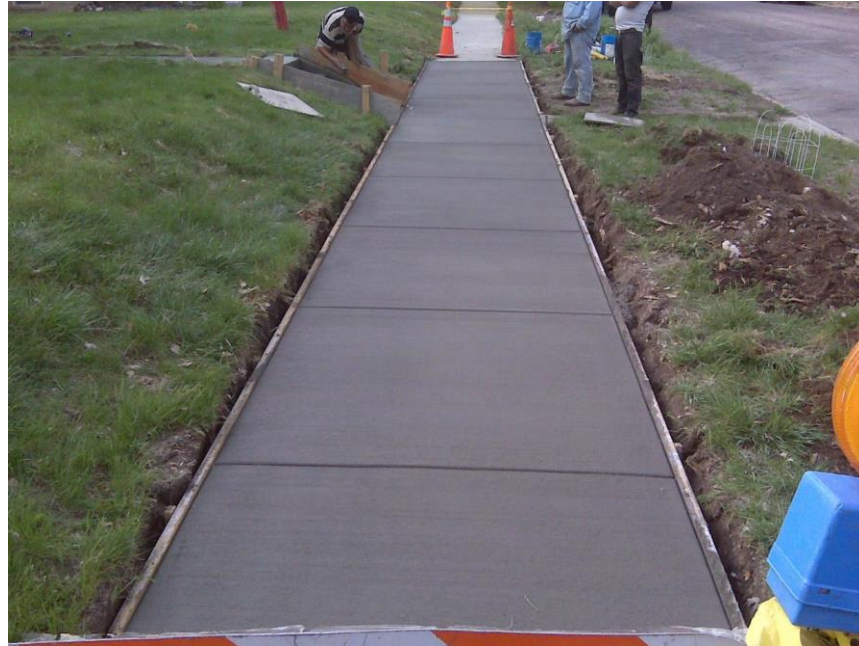
Concrete – The advantage of using concrete is that this accepted standard material is solid, doesn’t need an edge treatment, and can be permeable, reinforced, tinted, textured, and shaped and formed into curves around trees. It also can be leveled by slab jacking settled areas and grinding raised edges. The drawback of concrete is that it is rigid and not reusable, is usually not permeable, and depending on soil conditions and building codes may require a 4-inch-thick compacted base beneath 4-inch-thick sections. Roots are not allowed in the base material. This often means removal of roots, impacting tree health and stability.

Figure 17 - Concrete installation

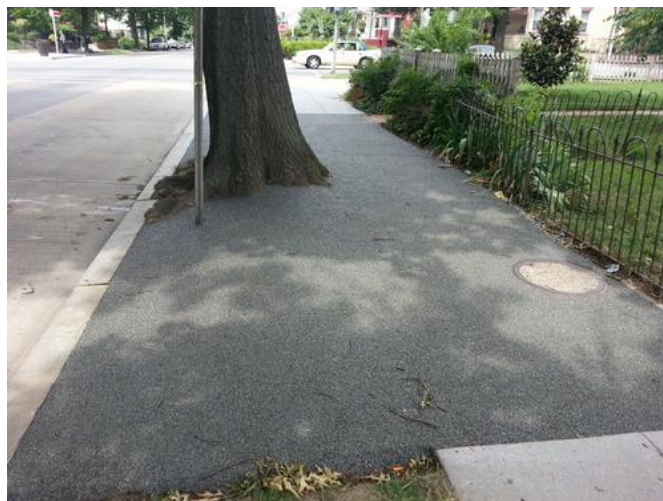
Asphalt – The advantage of using asphalt is that it is low in cost, thinner than concrete, and easily paved, shaped, and repaired. It should not need an edge form to remain in place after paving. It can be coated with a cement dust that absorbs oils and helps the surface color to be grayer, reducing heat absorption. It can also be stamped and coated with color. Asphalt doesn't require a thick base when used for a walking surface. It can be placed over roots and can be permeable. The roots can remain in the base material as long as they do not contact the asphalt layer. Future repairs may only require sawcutting the failed smaller area around the root and patching with more asphalt. Additionally, asphalt can be used as a ramping or topping (skin patching) material to alleviate a raised/offset concrete area. A drawback is that asphalt can heat up in the sun and become soft, it has a shorter lifespan than concrete, it is not reusable, and its appearance is not always desirable.

Figure 18 - Asphalt sidewalk and parkway

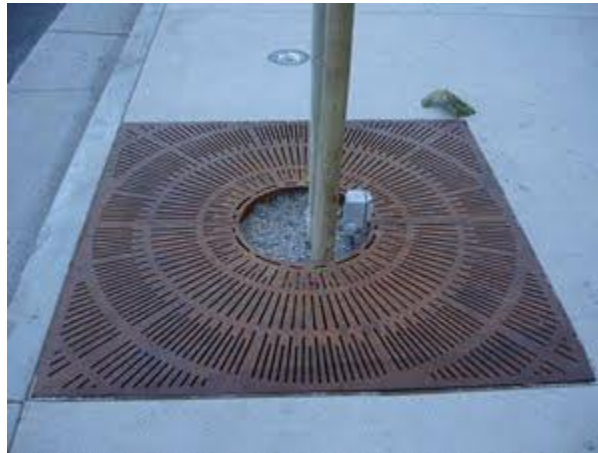
Tree Grates - Tree grates provide space around the tree as long as the grate opening doesn't cut into the trunk or trunk flare as the trees grow larger in girth. The opening can be enlarged by cutting the grate material but many cities fail to keep up with this requirement. Additionally, cutting the steel can rarely be completed on site. The grates offer permeability. On the downside, the grates must sit in a concrete footing. If the grate is 4 or 5 feet square, the space between the footing and trunk and roots is inadequate, and the grate frame is the first object to be lifted. Grates and installation are one of the most expensive treatments. If larger grates are used, 6' square, or 6' X 8' or 10', the soil area between the tree and the concrete frame footing may be adequate for long term growth, although larger grates are more expensive.

Figure 19 - Tree grate.
