**Sidewalk Master Plan
City of Sierra Madre
Public Works Department
January, 2015**

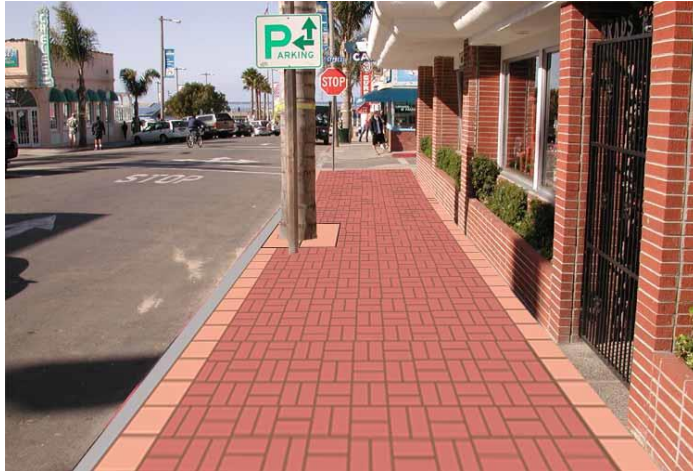
Bricks over Sand – The advantage of considering bricks include the fact that they are a common material, mid-range in cost, and have many colors. They can be placed over roots, shaped or curved, and are reusable. Bricks are considered more attractive than some treatments. There is permeability in the seams between the bricks. On the minus side, bricks require a rigid side form (wood or concrete), which can be lifted and cantilevered by roots. Bricks don't interlock, so individual bricks can be offset and not level. It is mid-range on the thickness scale.

Figure 20 - Brick sidewalk.

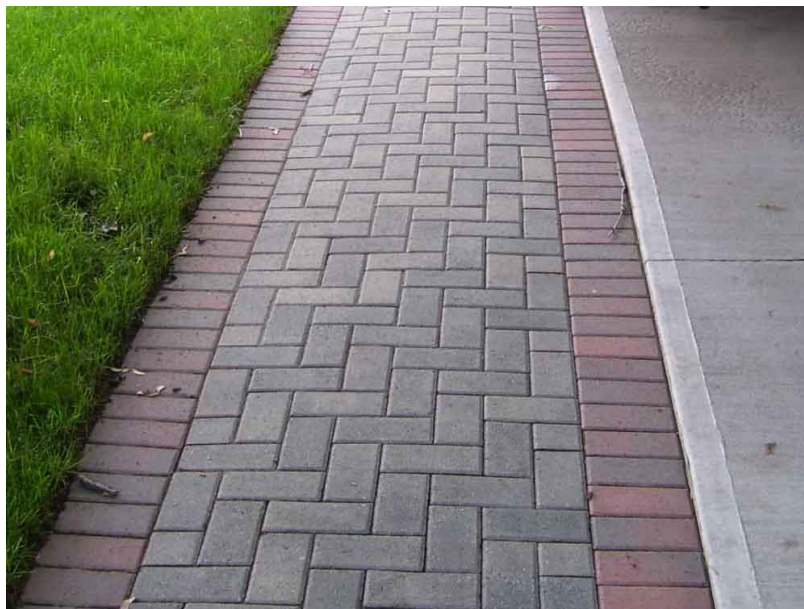
Interlocking Pavers – There are positive aspects of this material for new sidewalks. Pavers are flexible, reusable, shape-able, and decorative, and typically installed on a sand base that can be placed over roots. Pavers have permeability in the seams between the pavers. A disadvantage is that they need a concrete or rigid edge band on all sides to hold them in place and this band can be lifted by tree roots. They are mid to upper level on the thickness scale. Also, interlocking pavers usually require higher maintenance to keep them looking attractive and to ensure that the permeability of the pavers remains.

Figure 21 - Interlocking pavers.

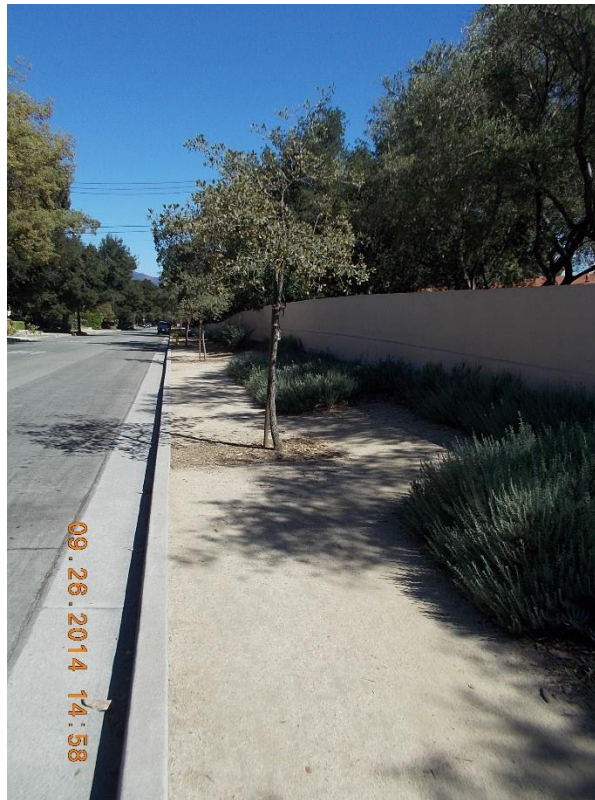
Decomposed Granite, aka Fine Rock Dust -This material is low cost and maintained by adding more or by re-grading. A binder can be used to help keep it together. Its border can be shaped, it can be laid over roots, and it doesn't need a deep base that can be placed over roots. On the

minus side, it requires an edge band on the sides to hold it in place, and this band can be lifted by roots. Also, the surface needs more maintenance and it has the potential for dust to be tracked into homes and businesses. It can erode on slopes and therefore should not be utilized on north-south running streets. The appearance may not be acceptable in some urban settings. This is mid to upper level on the thickness scale and once compacted or treated with a stabilizer to keep it from turning into mud when wet, is less porous.

Figure 22 - "DG" walkway.

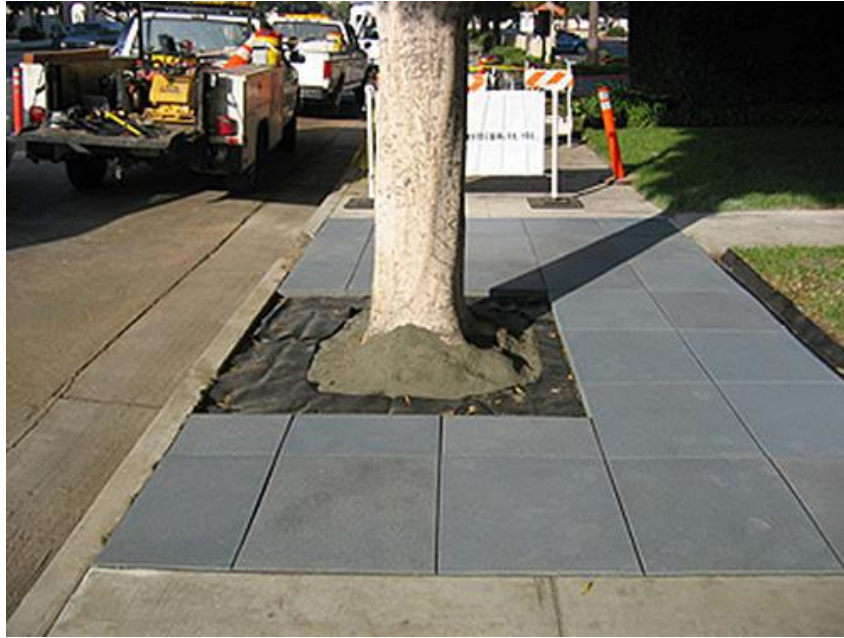
Rubber Panels – The advantages of using rubber panels is that they are made from recycled materials and are flexible, thin (around 2 inches), and re-usable. They can be cut to shape around trees and can be placed directly over roots. The base material can be filled in around roots and graded prior to laying the rubber panels. The panels have permeability in the seams between the panels. Also, rubber panels can be manufactured to have different finish appearances. The drawback of rubber panels is that an edge treatment is needed and if the final grade undulates (as in rolling hills), its edges may not match perfectly. Another disadvantage is that most installations are not designed for vehicle traffic. This material is on the lower end of the thickness scale.

Figure 23 - Rubber panels.

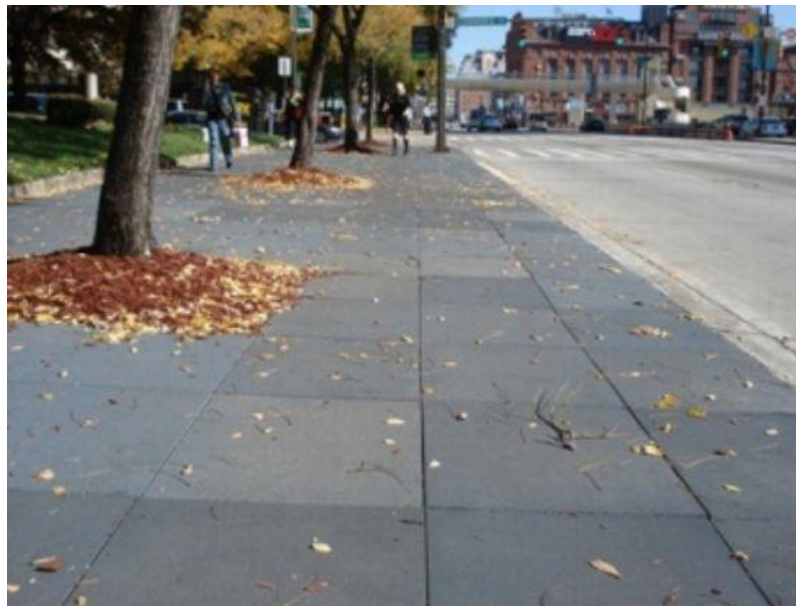
Plastic Panels – On the plus side, the plastic panels are made from recycled materials. They have some flexibility, thin (around 2 inches), and re-usable. They can be cut to shape around trees and can be placed directly over roots. The base material can be filled in around roots and graded prior to laying the plastic panels. The panels have permeability in the seams between the panels. Also, plastic panels can be manufactured to have different finish appearances. The panels stake directly to the ground and do not require edge treatments. On the minus side, the panels expand and need to have accurate spacing between panels. The panels don't dowel into adjacent concrete.

Figure 24 - Plastic panels.

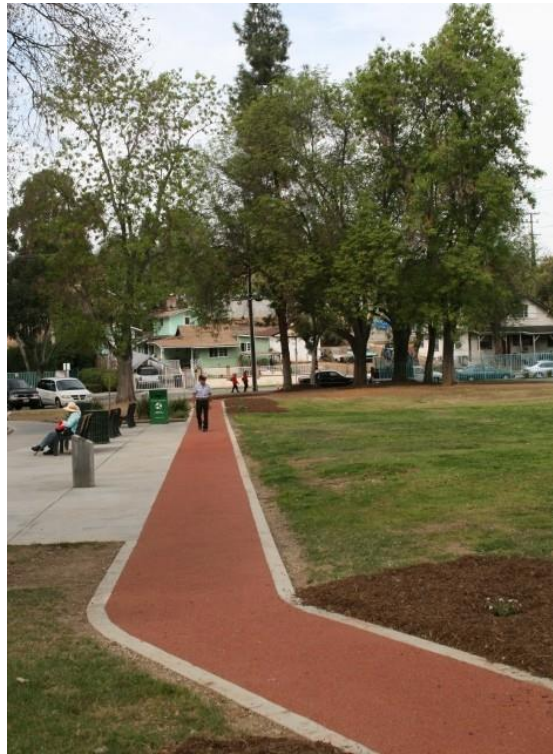
Poured-in-Place Rubber – Forms for this material may be removed after the product cures and it can be poured over roots. Other advantages are that it can be shaped or curved, can be placed in thinner sections (2 inch), it doesn't need a thick base, and can the top surface can be colored for enhanced appearance. Disadvantages are that it is not reusable, it is softer/more squishy than formed rubber panels/pavers, and its cost or contractor availability varies greatly by location. Another disadvantage is that most installations are not designed for vehicle traffic. This material is on the lower end of the thickness scale.

Figure 25 - Poured-in-place rubber.

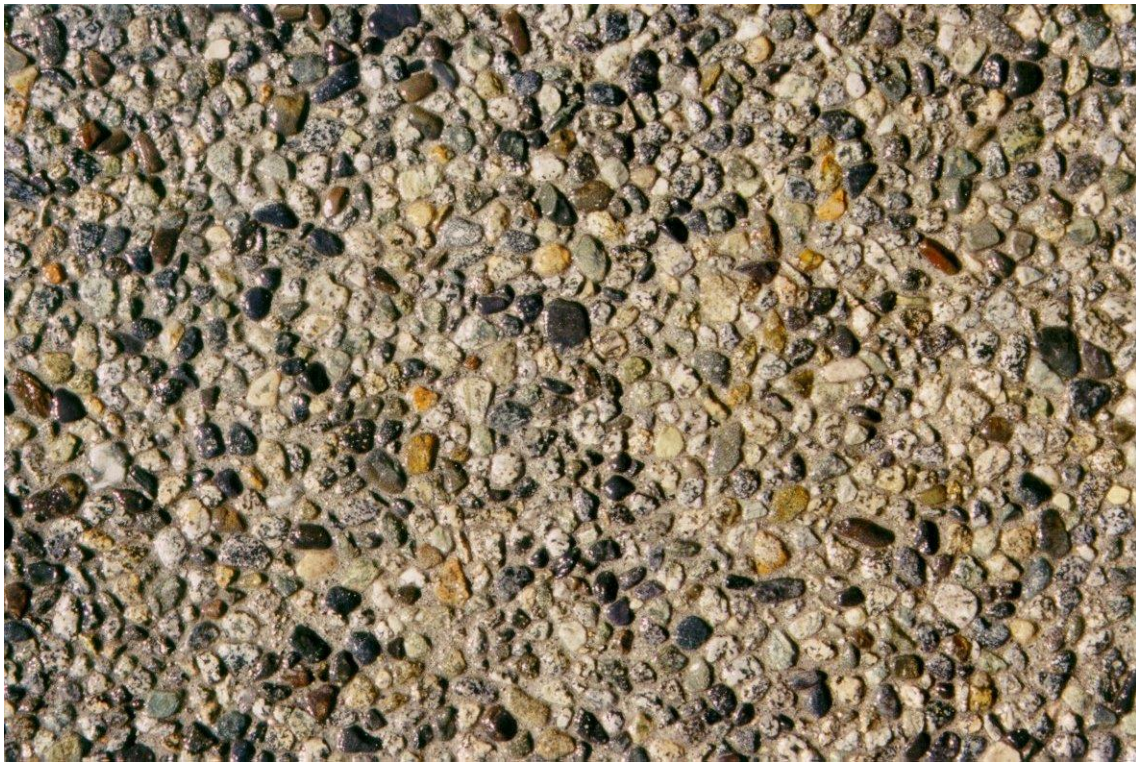
Polymer-Bonded Aggregate - This relatively new material consists of small aggregates of decorative stone that are glued together with a very viscous polymer which forms a bonded, porous walking surface. It doesn't need rigid side forms or a thick base. It can be shaped or curved and placed over roots. The forms are removed after the polymer cures. On the minus side, it is rigid—but repairs can be made by sawcutting and patching aggregate. As a material, it hasn't

been on the market long enough for long-term evaluation. This material is on the lower end of the thickness scale, although if designed for vehicle traffic, it may be thicker.

Figure 26 - Aggregate material close-up.

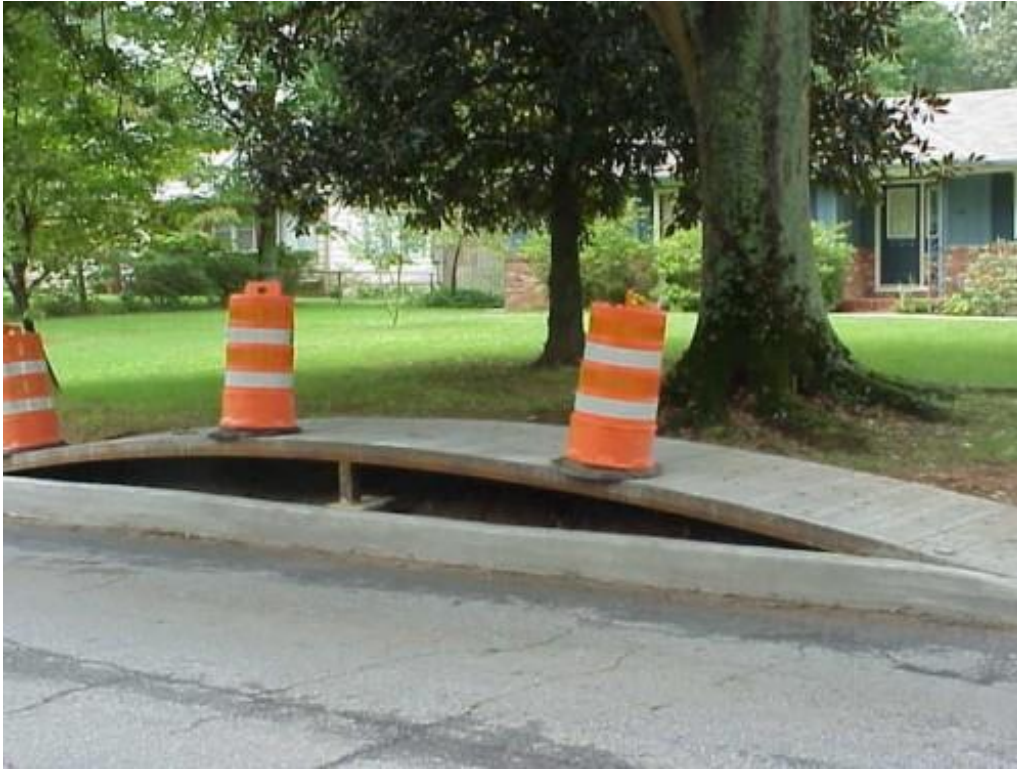
Root Bridging - The approach shown below creates a space between the sidewalk material and the existing tree roots while still meeting ADA standards. A slope is created using posts, piers, or arch supports; the sidewalk material is laid on the supports to leave a gap and space for the roots to grow without lifting the sidewalk. The big advantage of root bridging is that existing roots can be retained for health and stability. The bridging materials can vary, depending on height required, length of the repair area, and available budget. Common materials are wood, concrete, and composites. The main disadvantage of root bridging is that its design and construction is expensive. If the height of the bridge is equal to a step (6 - 8 inches) above the side grade, a railing may be necessary for safety. Sometimes soil can be used to match the edge of the bridge and remove the step-off potential.

Figure 27 - Root-bridging construction.
